THERMAL PERFORMANCE OF FAÇADES

2012 AIA UPJOHN GRANT
RESEARCH INITIATIVE

Final Report | November 2014

PAYETTE **RESEARCH**

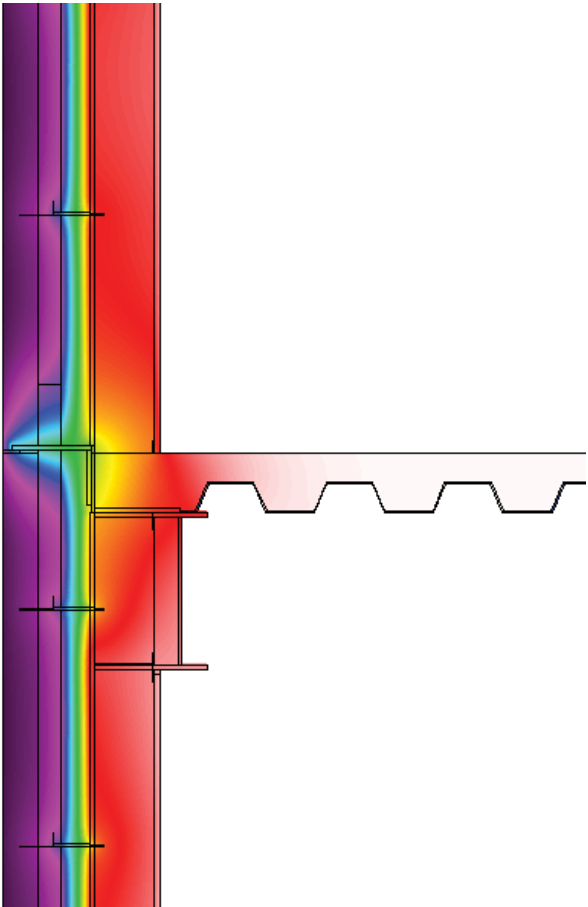
Traditional Masonry Wall with Galvanized Barrel Ties and a Continuous Galvanized Shelf Angle.

R-11.57
(-37%)

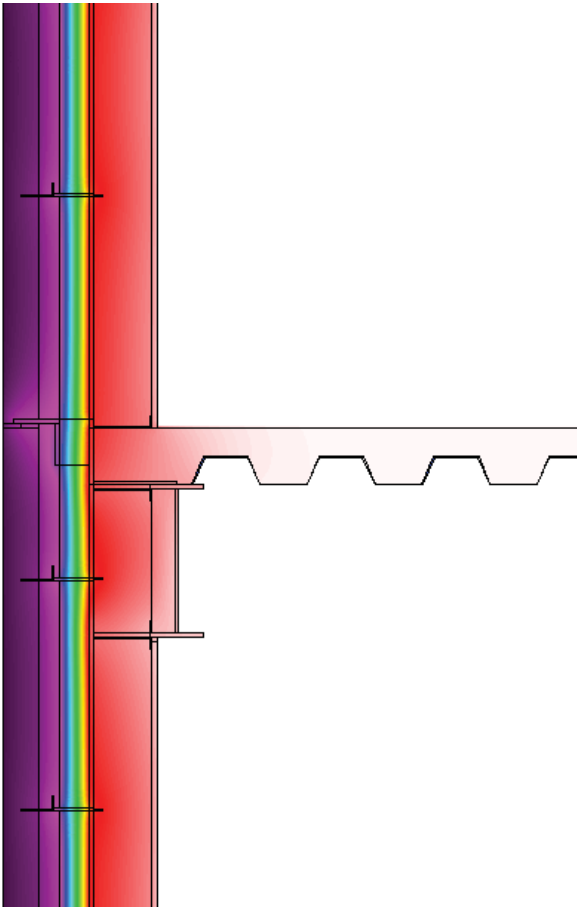
Improved Masonry Wall with Stainless Screw Ties and a Discontinuous Stainless Shelf Angle.

R-17.30
(-6%)

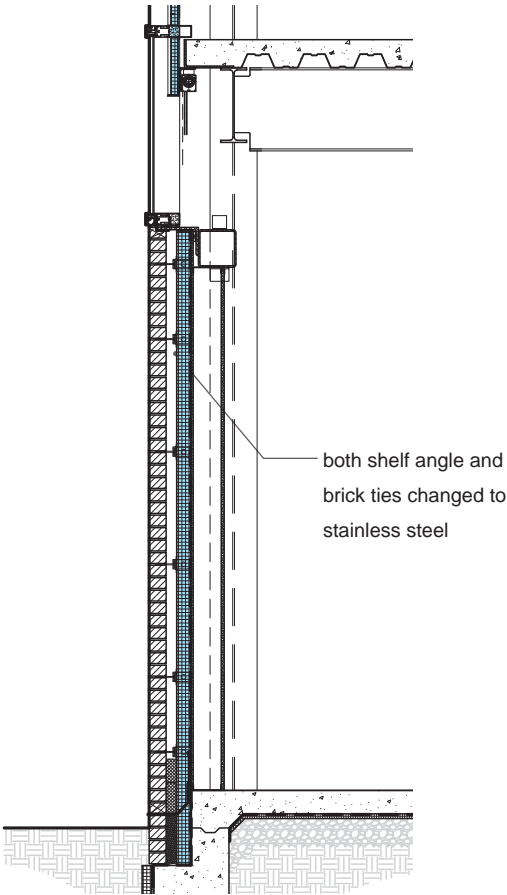
Thermally Improved Condition

R-15.85
(+9.8%)

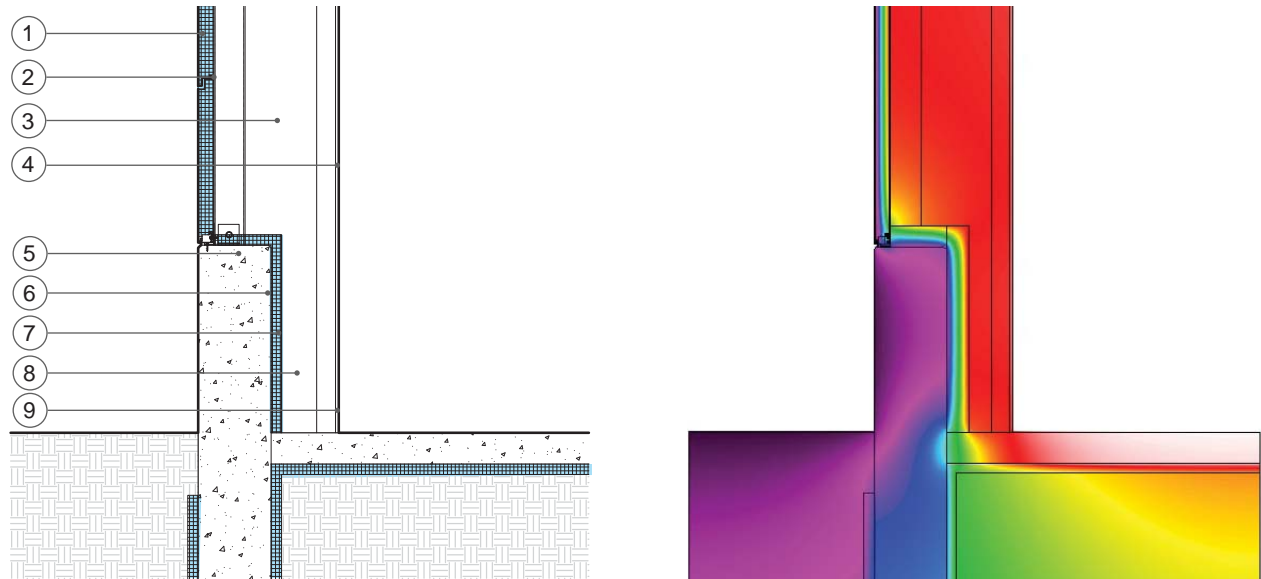
Thermally Improved Option A

R-8.59 (wall), R-14.21 (floor)
(+109% wall, +30.6% floor)

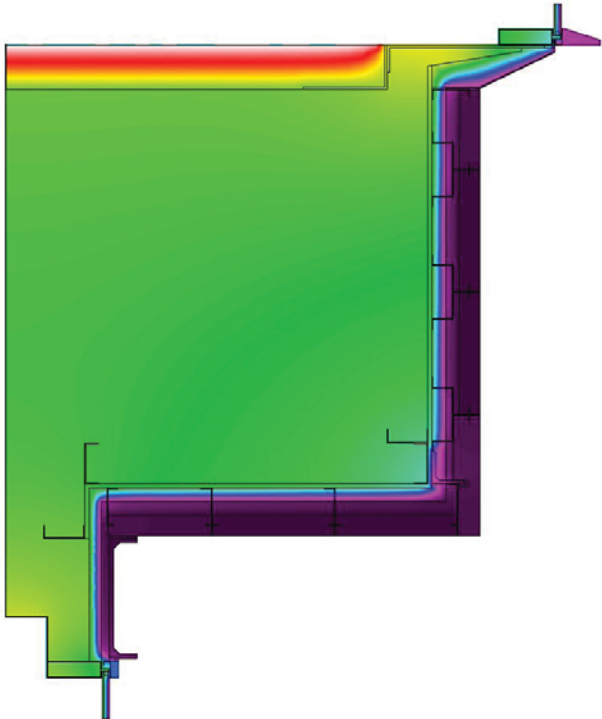
Thermally Improved Condition

R-17.2
(+6.8%)

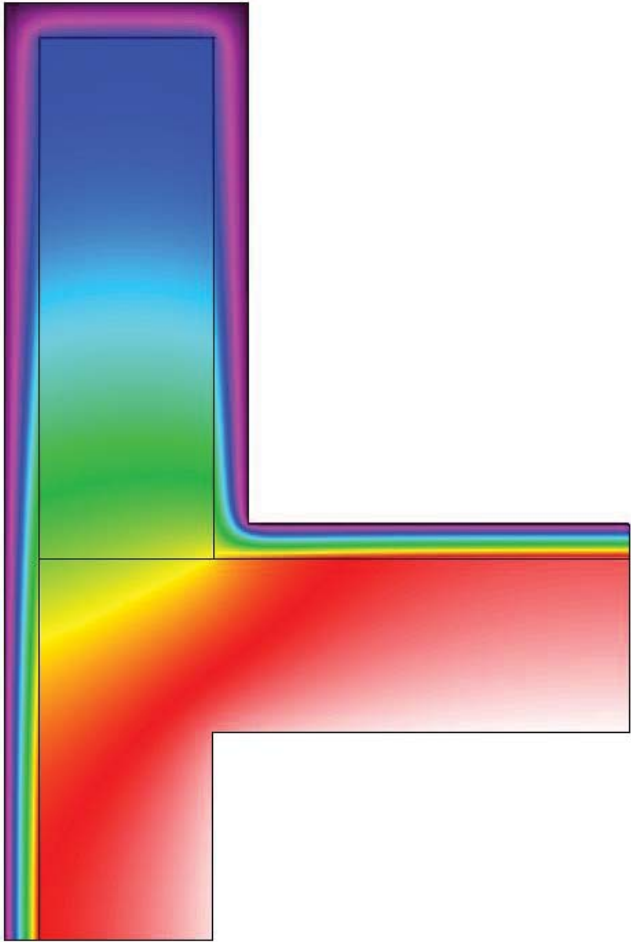
R-12.25
Insulating around 2'-6" tall parapet

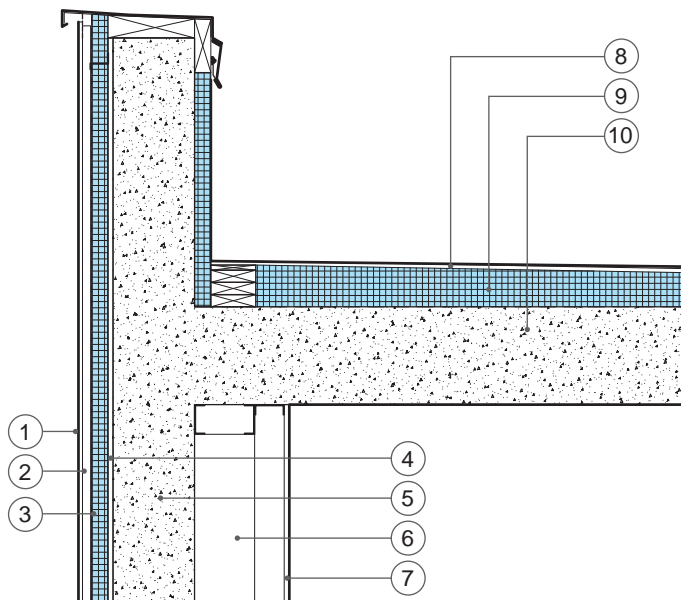
As-Built Condition

R-11.61
