APPENDIX- 04a | CURTAIN WALLS: Insulation Between Mullions (Typical)

APPENDIX- 04b | CURTAIN WALLS: Insulation within Mullion

APPENDIX- 04c | CURTAIN WALL: Wrapped Mullion

APPENDIX- 04d | CURTAIN WALL: Insulation Glazed In

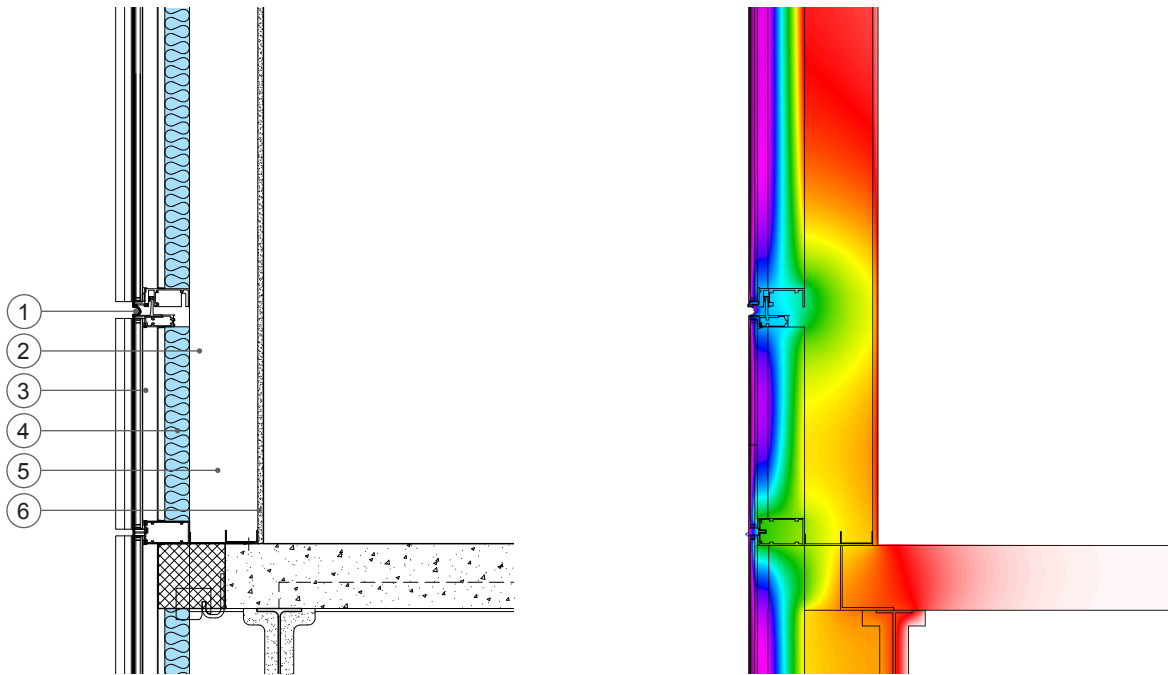
Calculated Baseline R-Value: 20.42 -
As-Built Condition
 Thermal Image R-Value: 5.75 - 72 %
 Simulated (THERM) R-Value: 6.17 - 70 %
Thermally Improved Condition
 Simulated (THERM) R-Value: NA

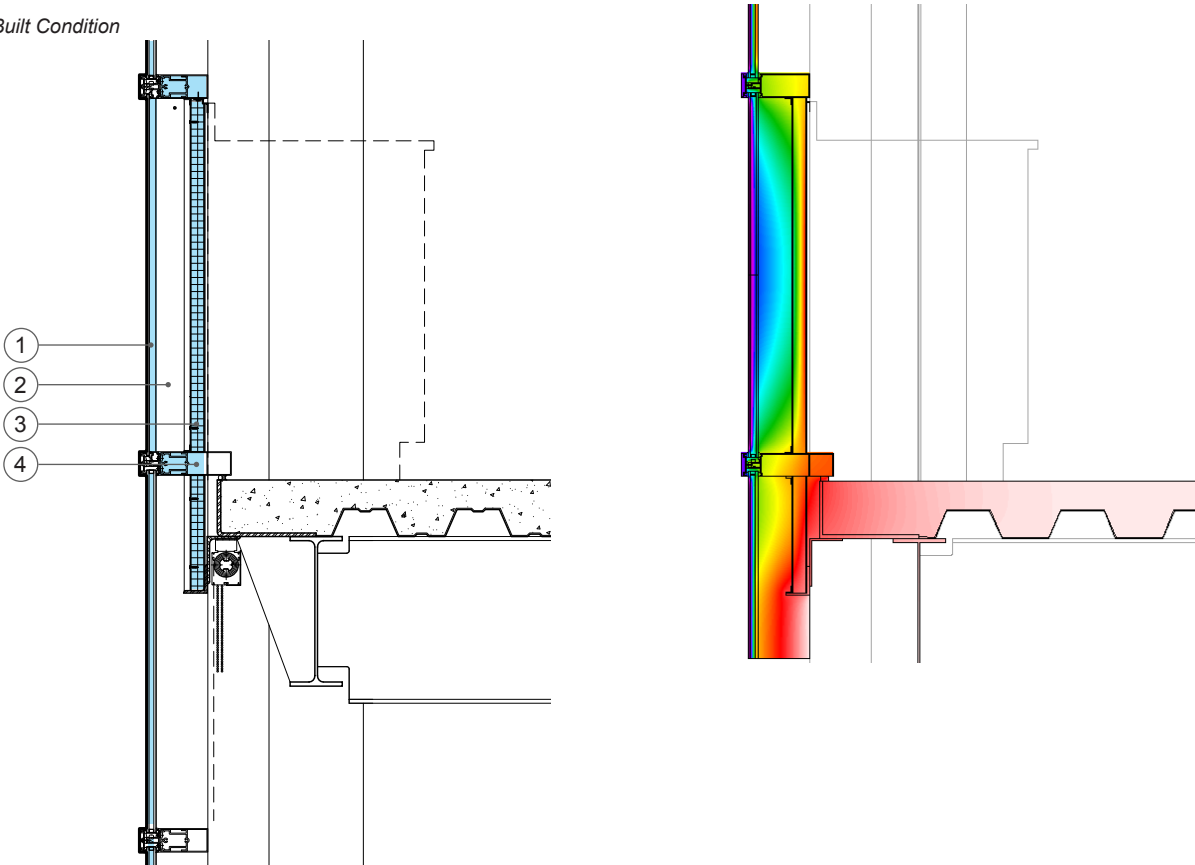
Calculated Baseline R-Value: 14.16 -
As-Built Condition
 Thermal Image R-Value: 6.18 - 56 %
 Simulated (THERM) R-Value: 4.92 - 62 %
Thermally Improved Condition
 Simulated (THERM) R-Value: NA

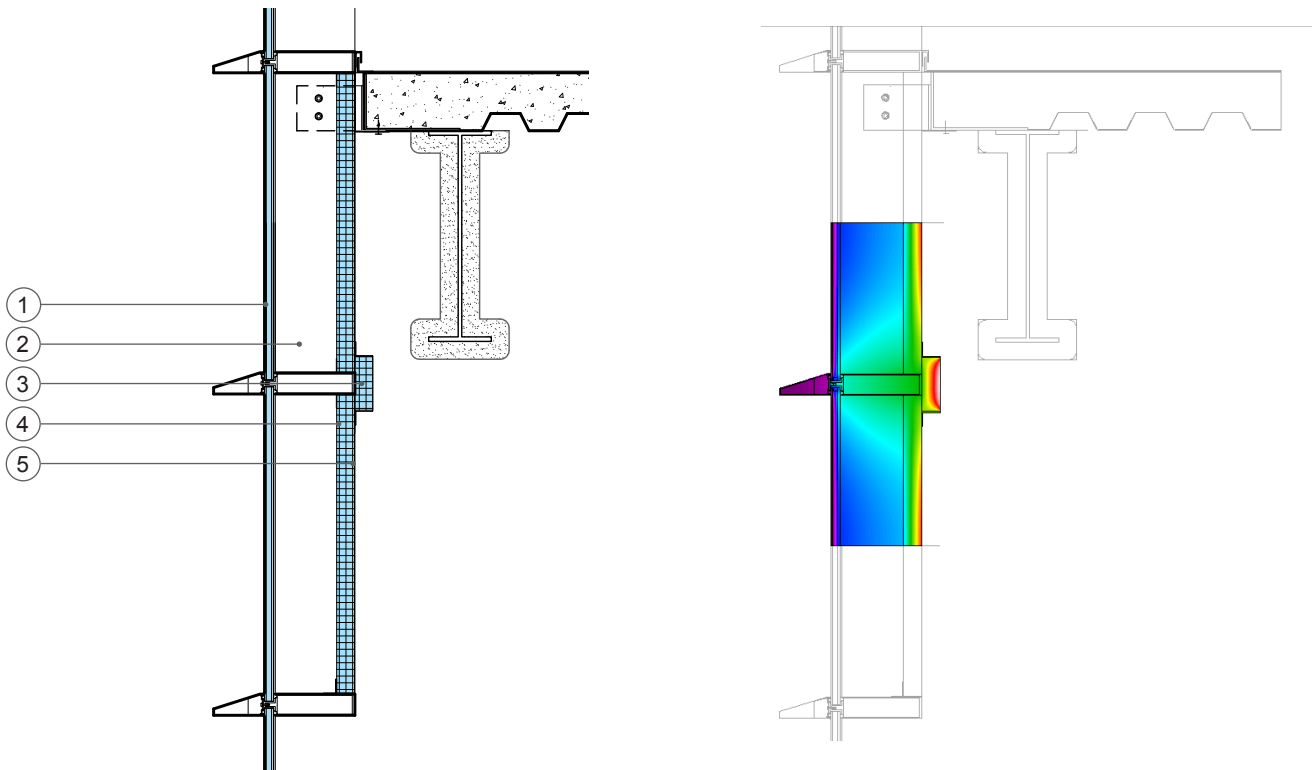
Calculated Baseline R-Value: 13.12 -
As-Built Condition
 Thermal Image R-Value: NA
 Simulated (THERM) R-Value: 5.11 - 61 %
Thermally Improved Condition
 Simulated (THERM) R-Value: 10.86 - 17 %

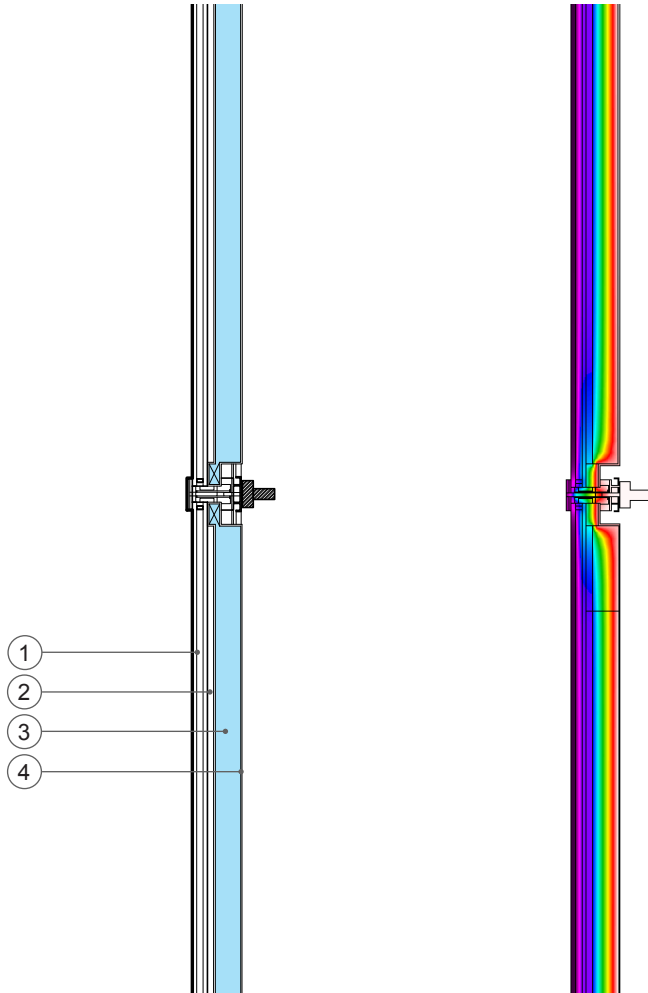
Calculated Baseline R-Value: 11.81 -
As-Built Condition
 Thermal Image R-Value: NA
 Simulated (THERM) R-Value: 8.09 - 31 %
Thermally Improved Condition
 Simulated (THERM) R-Value: NA
