THERMAL PERFORMANCE OF FAÇADES

2012 AIA UPJOHN GRANT
RESEARCH INITIATIVE

Final Report | November 2014

PAYETTE **RESEARCH**

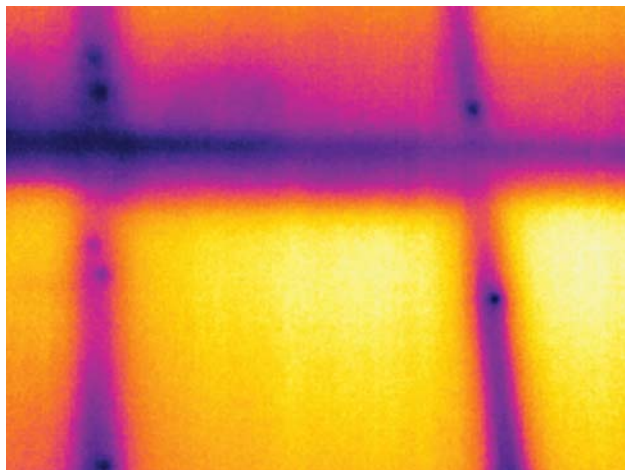
Infrared Image of Z-girt supports at a Rainscreen

In our thermal images of rainscreen façades, we observed a decrease in thermal performance that ranged from 20% to 60% less than the design intended performance, with the majority around a 45-55% decrease. The systems we selected for study all had between two to three inches of insulation. We looked at a rainscreen with horizontal Z-girts, vertical Z-girts, and a clip-based system. Not surprisingly, the continuous Z-girts, whether horizontal or vertical, performed similarly. In both orientations, Z-girts demonstrated an R.7.7 reduction in the assembly's R-value or roughly a 45-55% reduction in performance depending on the insulation thickness.

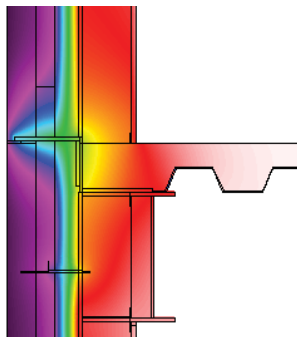
Traditional brick shelf angle

superstructure, passing through the insulation layer. Taken alone, these steel shelf angles account for an approximate 35% decrease in the R-value. That figure would be far worse if the steel was protected with highly conductive coated copper flashing as it may have been several years ago. Today, we might consider using a membrane flashing and making the entire angle out of stainless steel (which has 1/3 the conductivity of carbon steel). This sort of change could reduce the performance impact of the shelf angle from 35% down to 29%.

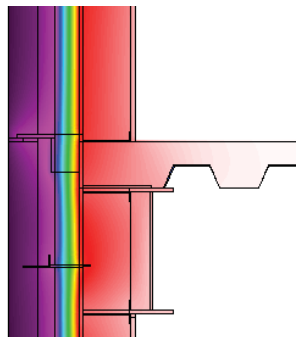
Thermally broken brick shelf angle

In order to truly minimize the thermal impact from the shelf angle, however, we investigated an option, advocated by Building Science Corporation (Lstiburek 2008), of supporting the shelf angle with evenly spaced blades or brackets that allow the shelf angle to remain entirely outboard of the insulation, thereby creating intermittent rather than continuous thermal bridges. Providing a thermal break between the brackets and the shelf angle and then conservatively assuming these brackets are spaced at 48" inches on center, results in a substantial improvement in performance. In this system we saw only a 12% decrease in the R-Value from the support structure. This could be reduced down to 3% if the blades were made of stainless steel.

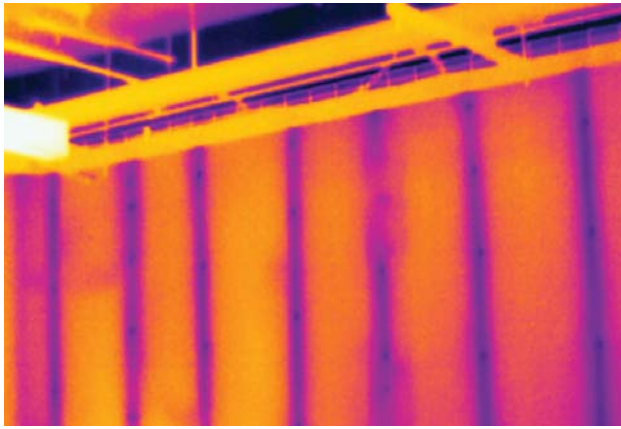
Infrared Image showing studs directly attached to existing wall

Studs directly attached to existing wall

59% of baseline calculated R-value

studs flush against the exterior construction, resulting in an R-value that was 55% less than the calculated R-value. The second building pulled the studs back by 1", allowing for half of the applied insulation to be continuous and decreasing the R-value by only 15%. Consequently, that façade was observed to have a higher R-value than one with the studs penetration through to the exterior, despite having less insulation. The third façade took the studs back even farther, completely separating them from the insulation and as a result the simulated R-value was nearly identical to the measured values.

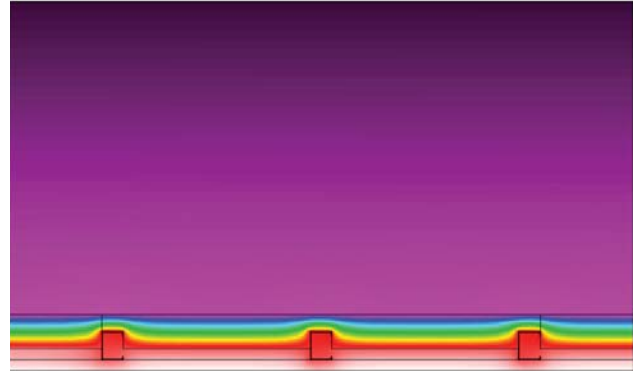
Studs pulled 1" back from existing wall

16% of baseline calculated R-value

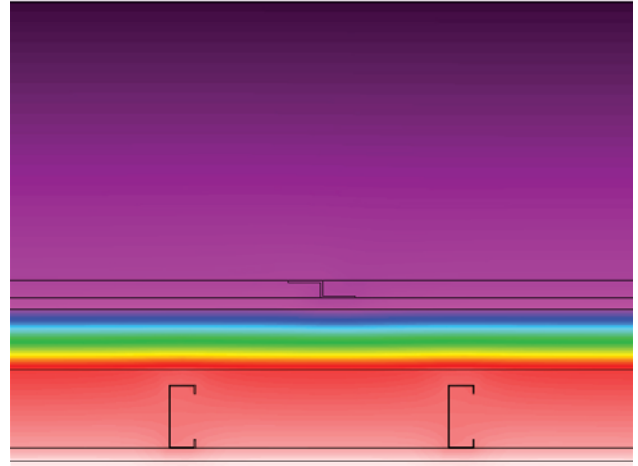
Studs separated from insulation

2% of baseline calculated R-value

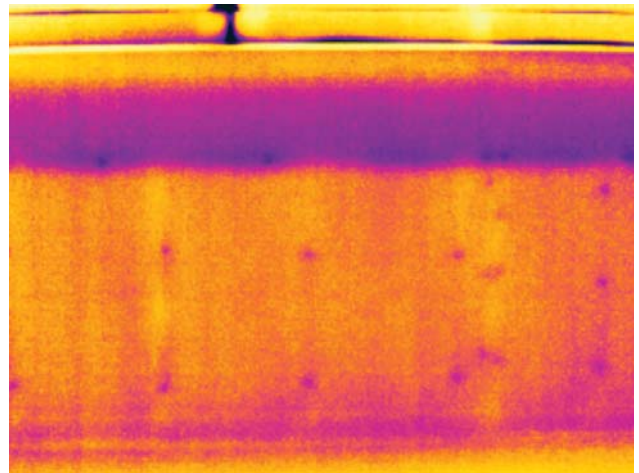
Infrared image of structural support at window proud of insulation

superstructure, this will lead to substantial performance impact.

It is essential to avoid continuous support and assure that outriggers or brackets are used to create only the bare minimum number of thermal bridges. In one test case, we replaced a continuous section of tube steel with intermittent blades that cantilevered out to support a brick lintel and effected a 68% reduction in heat flow through the assembly. While our study was typically based on brackets spaced at 48" +/- on center, it should also be possible to increase spans well over 96" to realize far greater performance (at the expense of heavier structure).

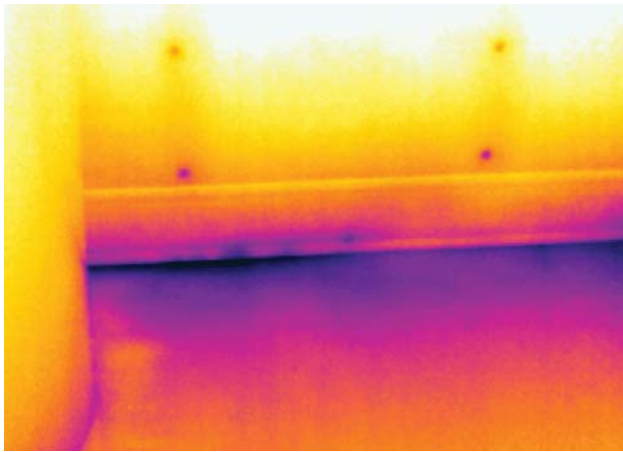
The wall transition above the foundation wall is consistently a problematic area for thermal performance. This transition has been observed to affect the wall R-value by as much as 70-75% for three factors. The transition of wall assemblies is usually necessary because most wall assemblies above grade are not able to withstand conditions below grade. The switch of wall assemblies usually results in an offset and discontinuity of the insulation. The second reason this is a difficult area to detail is that this offset typically occurs at the termination of waterproofing which results in the metal flashing spanning across the insulation, creating an additional thermal bridge. The third factor to take into account is that the transition often occurs where the slab on grade meets the foundation wall. The structural stability of the connection creates another discontinuity of the insulation that is hard to overcome.

Infrared image looking at the foundation wall transition

To determine ways to improve the performance we looked at a number of options for improved details. The first was a structural thermal break in the concrete slab where it connects

to the foundation wall for a foundation wall that was insulated on the interior. This allows for some thermal continuity between the slab insulation and the interior insulation. The most improved option was a concrete foundation wall built of a sandwich panel with insulation integral within the concrete. This allowed the insulation to be as continuous as possible with the above grade insulation, and minimizes the shelf condition at grade.

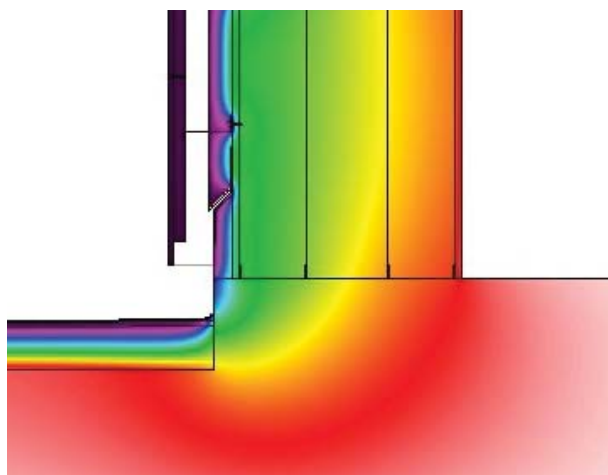
THERM Simulation of roof to wall transition

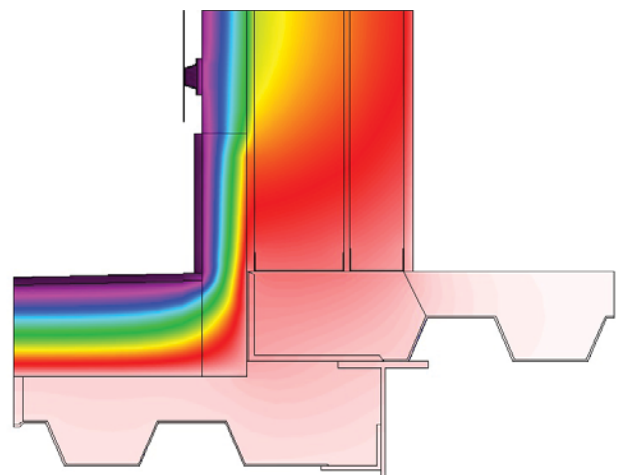
THERM Simulation of roof to wall transition with continuous insulation

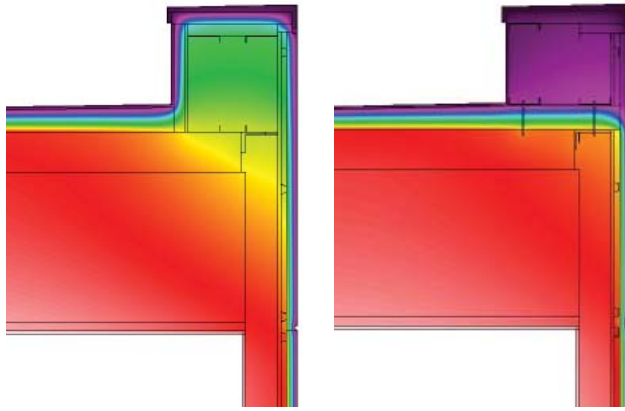
Moving into greater detail, we also studied typical construction methods for parapet systems. Considering cold formed metal framing parapets and cast-in-place concrete assemblies, we found that R-value were reduced from a theoretical system 63% and 50%, respectively. This decrease in thermal performance was largely due to the large gap in insulation that occurred at the parapet. We also studied a third case where a cold formed metal framing parapet had been installed

THERM Simulation of parapet: insulating around(left) versus insulating under the parapet(right)

We studied two systems for improving the typical details. The cold formed metal framing option had continuous insulation under the parapet to the façade insulation to create a continuous thermal barrier. To support the structure of the parapet, we added a metal framing structure and included intermittent connection back to structure using lower-conductivity materials such as stainless steel bolts. This increased the R-value in the assembly by 25-65% when compared to the baseline system. For the concrete parapet, we tested a commercially available structural thermal break designed for concrete slabs (balconies) and installed this in a vertical orientation. This improvement decreased the heat flow through the assembly by 27%.

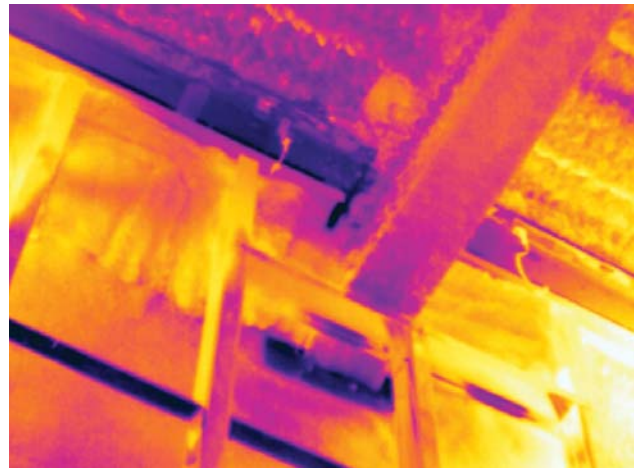
Since existing buildings are typically insulated from the interior during a renovation, the structural members can cause substantial thermal bridges. In load bearing masonry buildings, common in the Northeast, the bearing support for beams are often embedded in the exterior wall causing the steel beam to penetrate the insulation and causing a significant thermal bridge. This was observed in thermal images to decrease the thermal performance of the adjacent wall by 72% in thermal images. In photographed details, Teflon spacers had been used where the angles connected the embedded steel to the beam web. Because the beam was still extending through the insulation, the spacers which were intended to lessen the thermal bridge from the beam did not have a significant impact.

Infrared image of beam connection at existing wall

While existing beams pose a difficult challenge to improving this condition, when new structural beams are added as part of the renovation, there is an opportunity to improve the façade's thermal performance. An alternative option was investigated that employed a structural thermal break at the thermal barrier of the envelope. Many manufactures have thermal breaks for structural steel connections, however because structure typically needs to be fire rated, careful review of the thermal break options is needed as only a few met both the thermal and fire rating requirements for the connection. The thermal break can be coated in cementitious

fire-proofing spray along with the rest of the steel and placed in-line with the insulation to reduce the heat flow around the surrounding assembly by 36%.

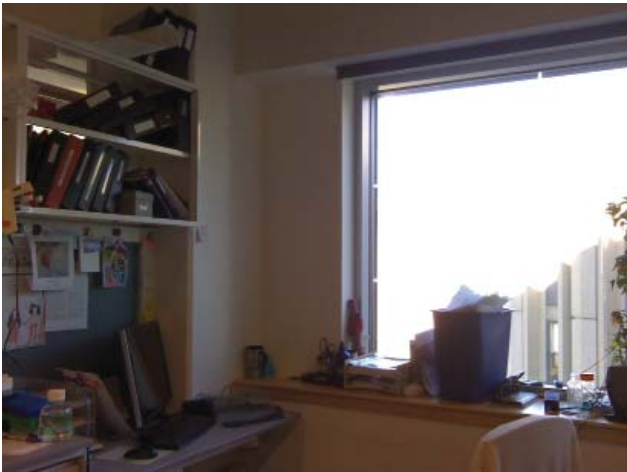
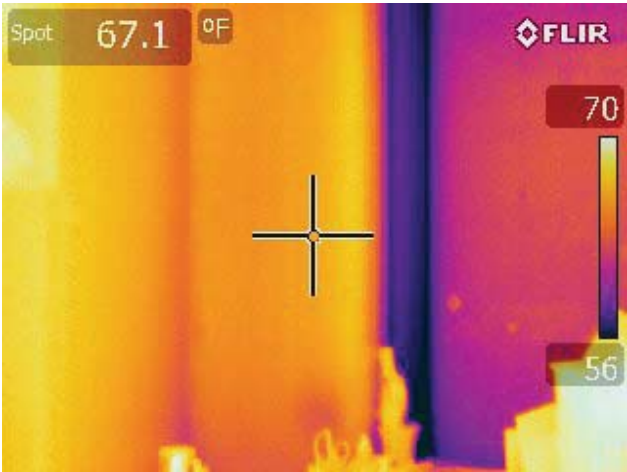
Calculated Baseline R-Value:	13.86	-
As-Built Condition		
Thermal Image R-Value:	6.19	- 55%
Simulated (THERM) R-Value:	5.60	- 60%
Simulated (THERM) R-Value just support connection:	7.20	- 48%

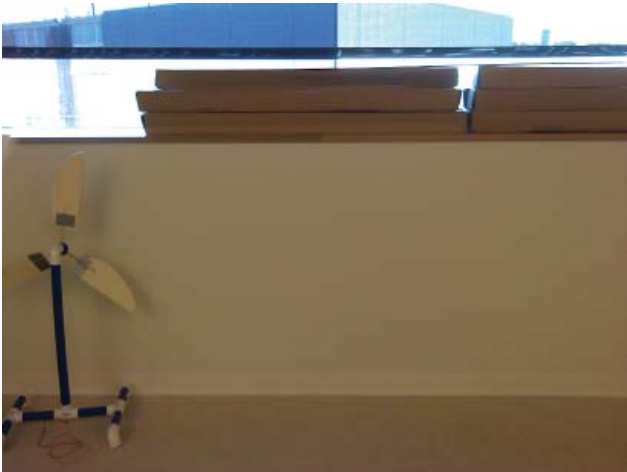
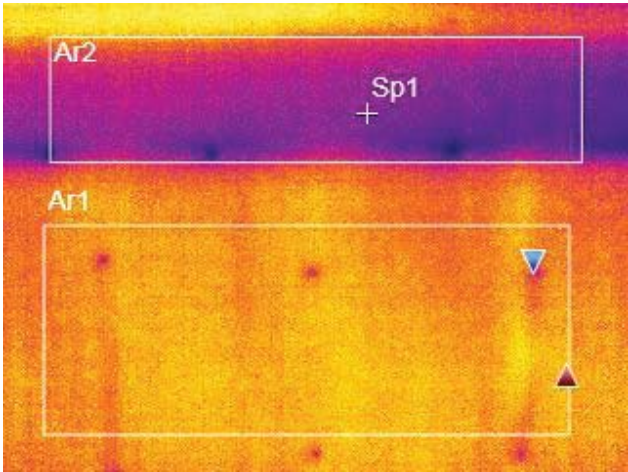
Calculated Baseline R-Value: 16.90 -
As-Built Condition
Thermal Image R-Value: 9.21 - 46 %
Simulated (THERM) R-Value: 11.05 - 35 %
Thermally Improved Condition
Simulated (THERM) R-Value: 16.2 - 4 %

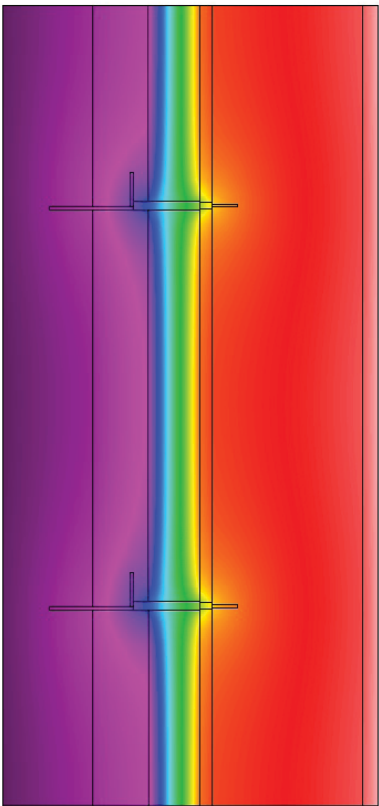
16x16 Galvanized Barrel

R-12.54
(-15%)

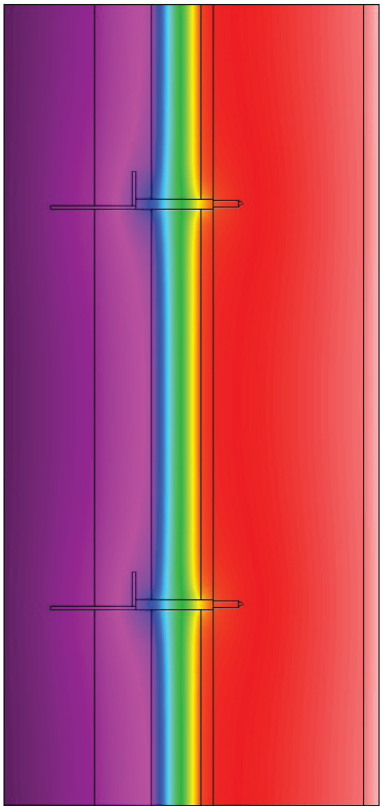
16x16 Stainless Barrel

R-13.72
(-7%)

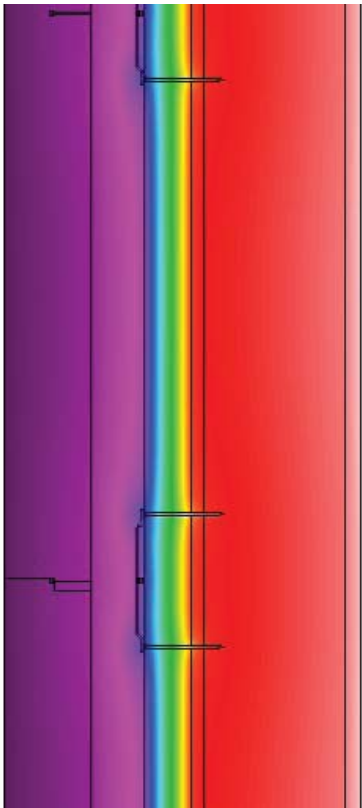
16x24 Galvanized Screw

R-13.72
(-7%)

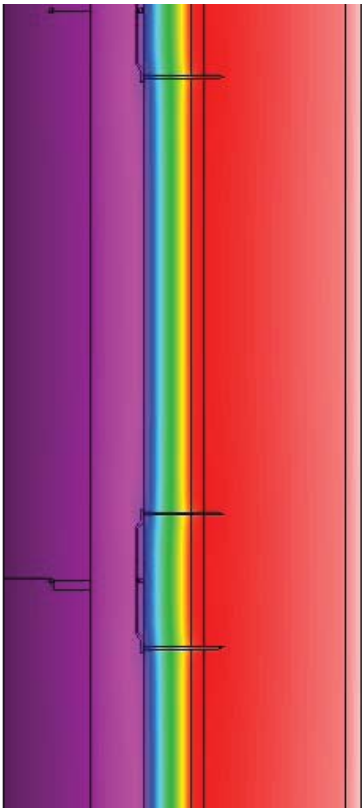
16x24 Stainless Screw

R-14.46
(-2%)

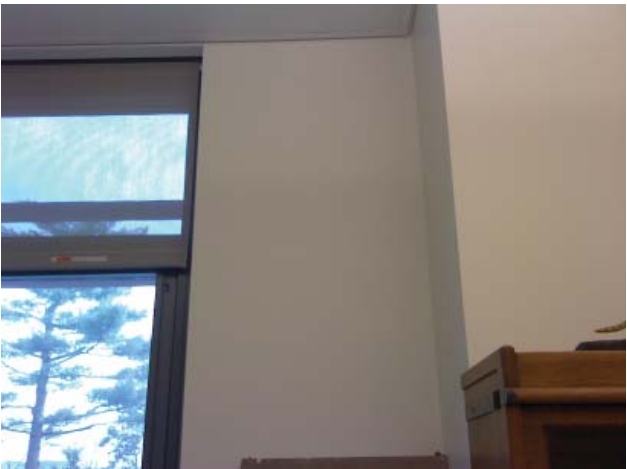
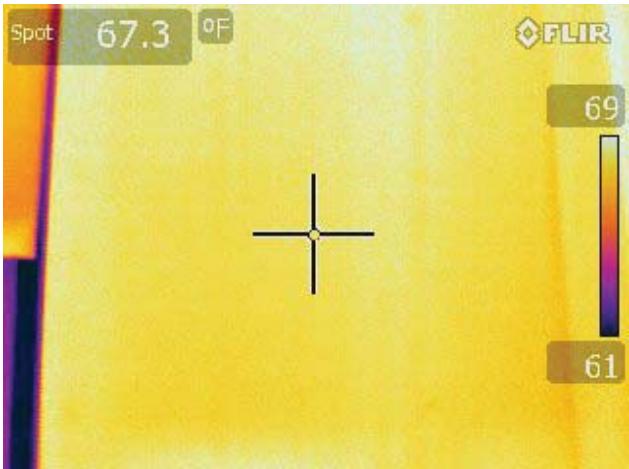
As-Built Condition
Thermal Image R-Value: 12.3 - 20 %
Simulated (THERM) R-Value: 13.28 - 14 %

Thermally Improved Condition
Simulated (THERM) R-Value: 13.68 - 11 %

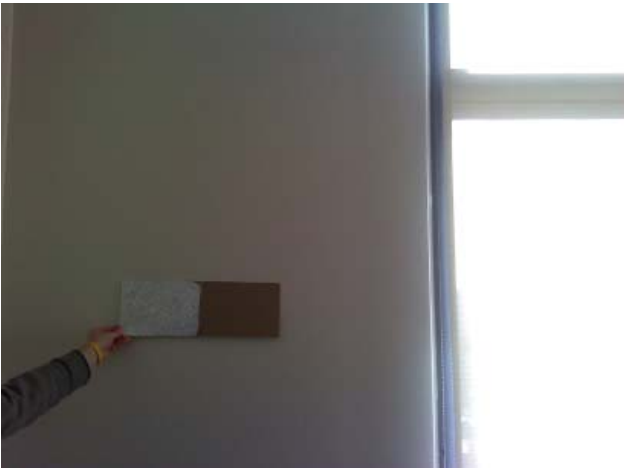
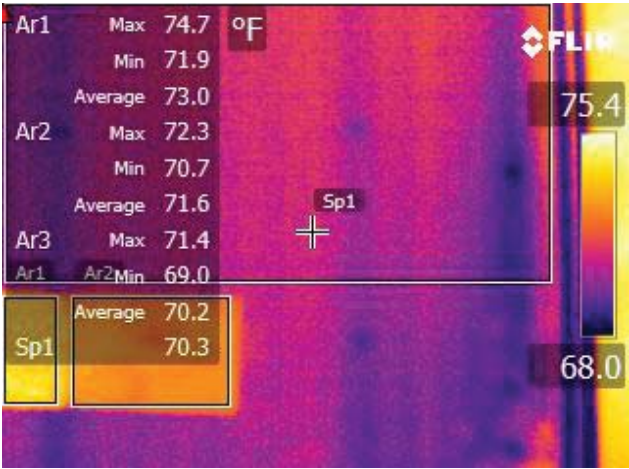
As-Built Condition
Thermal Image R-Value: 6.5 - 58 %
Simulated (THERM) R-Value: 9.47 - 40 %

Thermally Improved Condition
Simulated (THERM) R-Value: 10.53 - 33 %

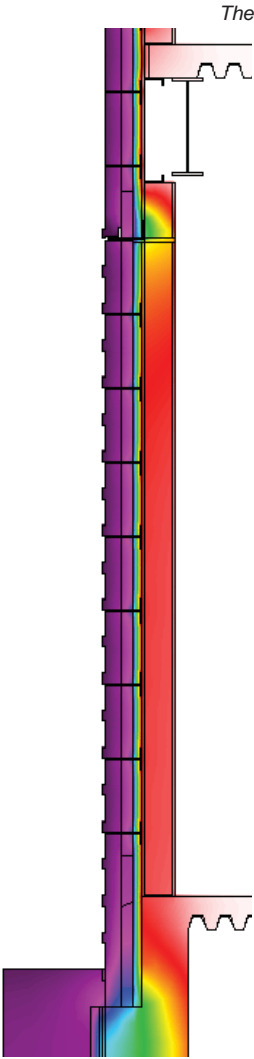
both shelf angle and
brick ties changed to
stainless steel

R-10.53
(+11%)

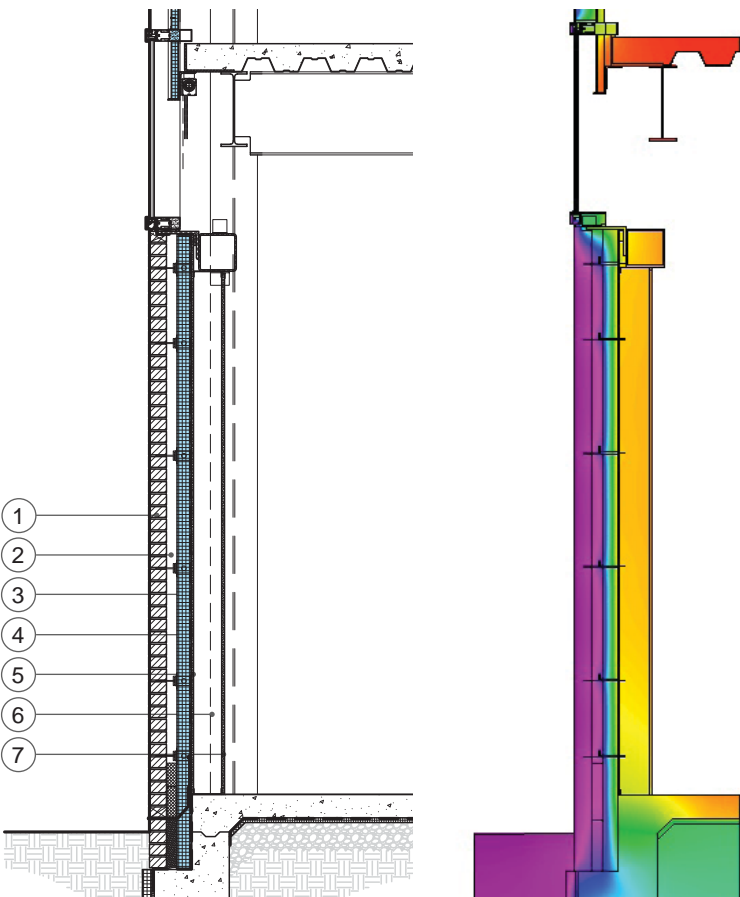
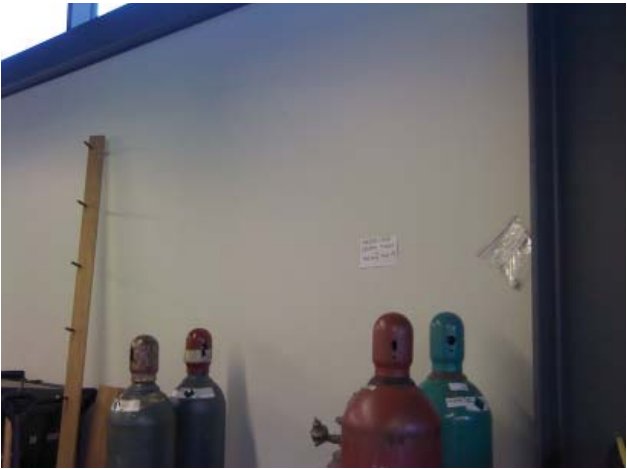
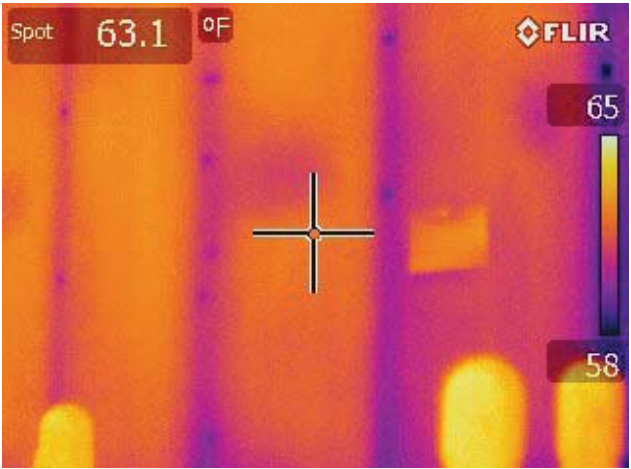
Calculated Baseline R-Value:	17.89	-
As-Built Condition		
Thermal Image R-Value:	8.4	- 53 %
Simulated (THERM) R-Value:	14.43	- 19 %
Thermally Improved Condition		
Simulated (THERM) R-Value:	15.85	- 11 %

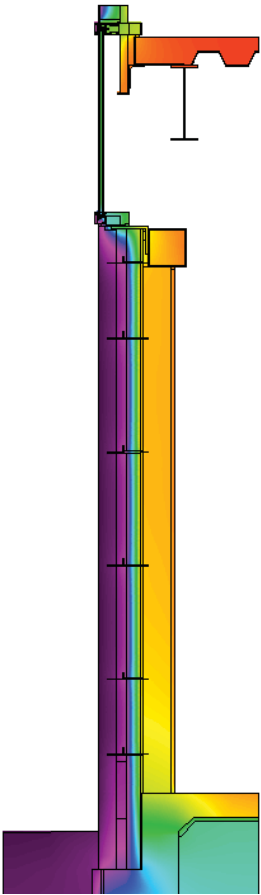
R-15.85
(+9.8%)

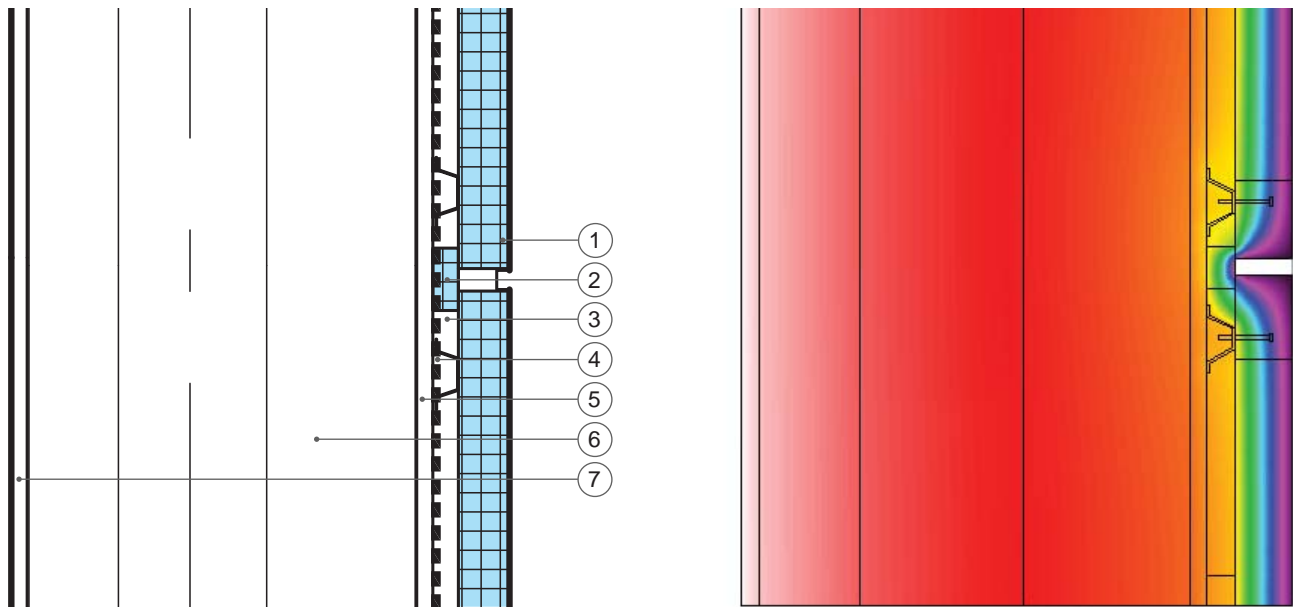
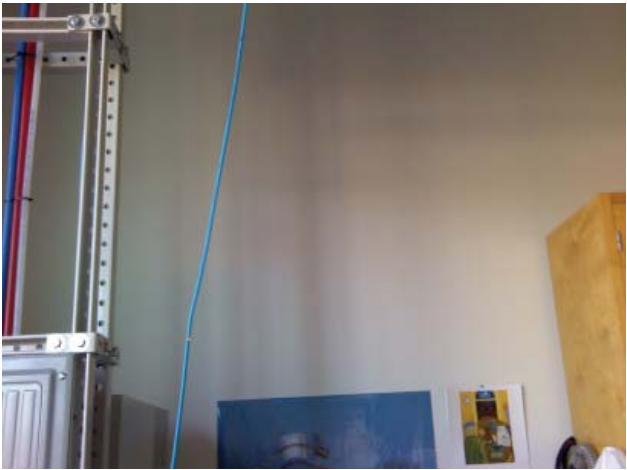
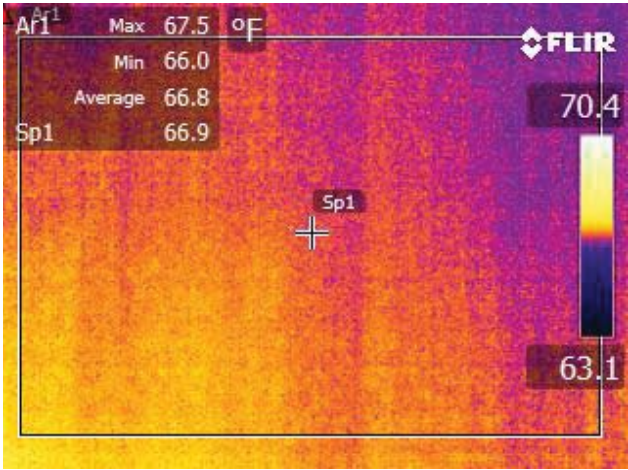
APPENDIX- 03a | METAL PANEL WALL SYSTEMS: Metal Panels with Insulated Joints

Calculated Baseline R-Value:	19.34	-
As-Built Condition		
Thermal Image R-Value:	18.67	- 3 %
Simulated (THERM) R-Value:	17.55	- 9 %
Thermally Improved Condition		
Simulated (THERM) R-Value:	N/A	-

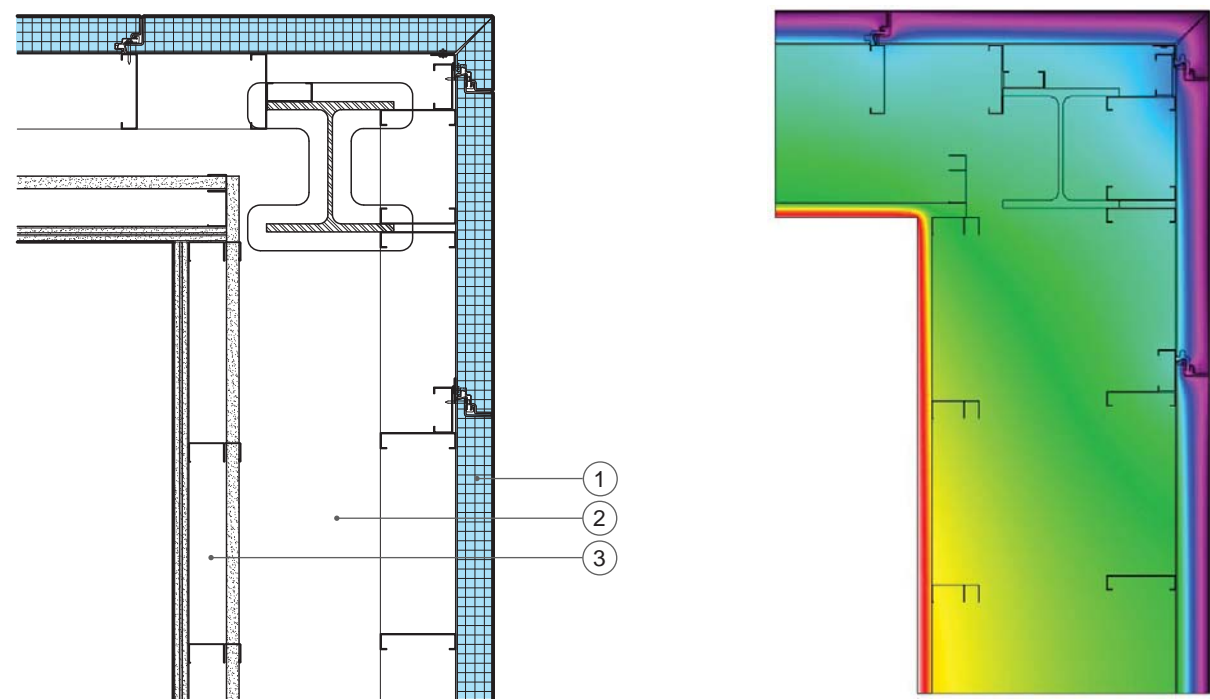
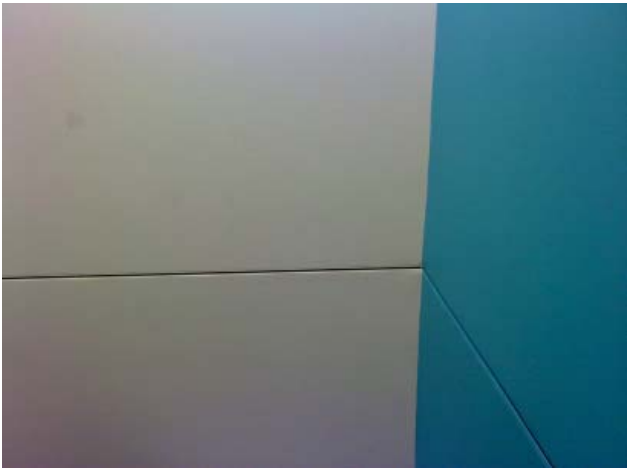
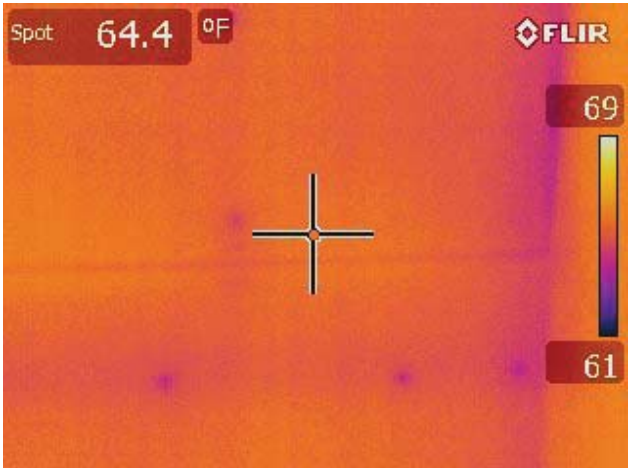
As-Built Condition
Thermal Image R-Value: 6.80 - 67 %
Simulated (THERM) R-Value: 4.23 - 80 %

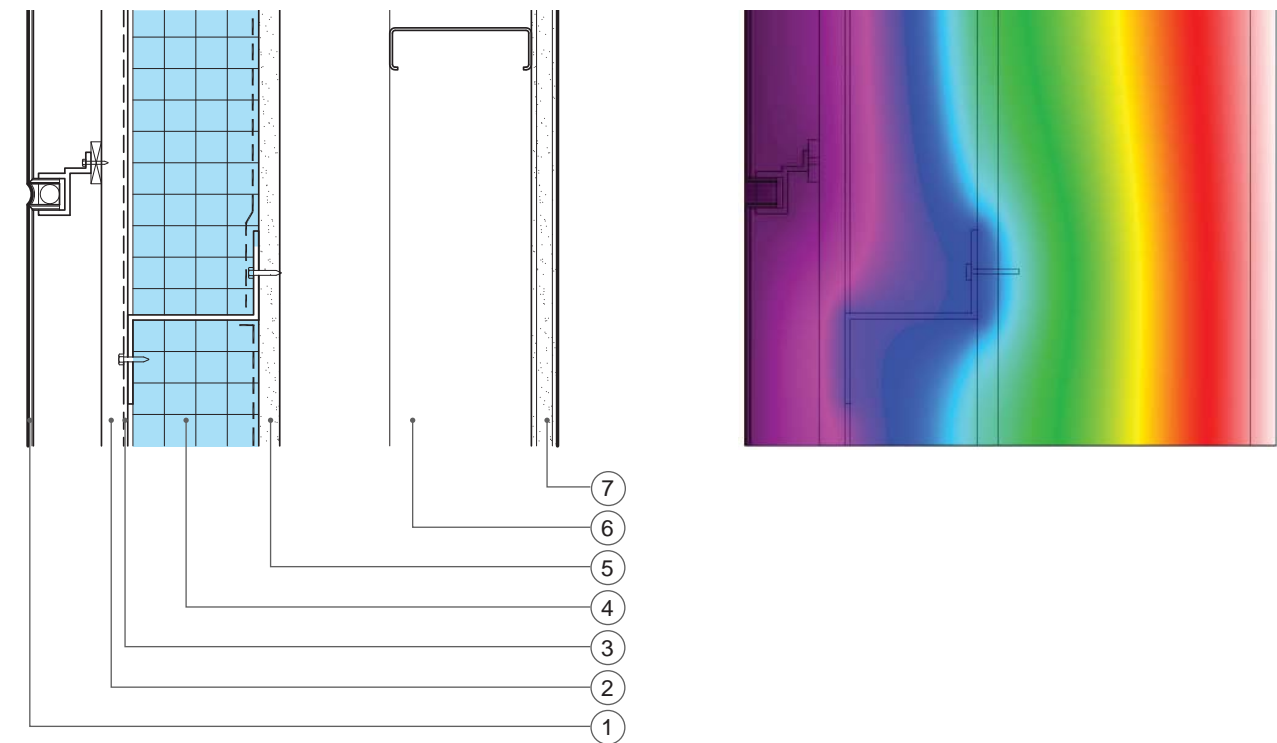
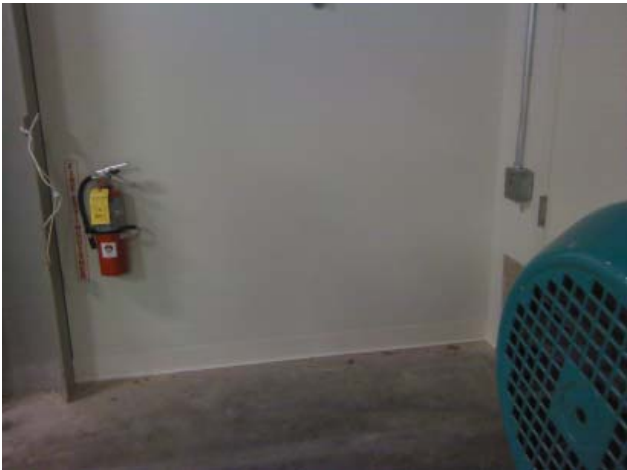
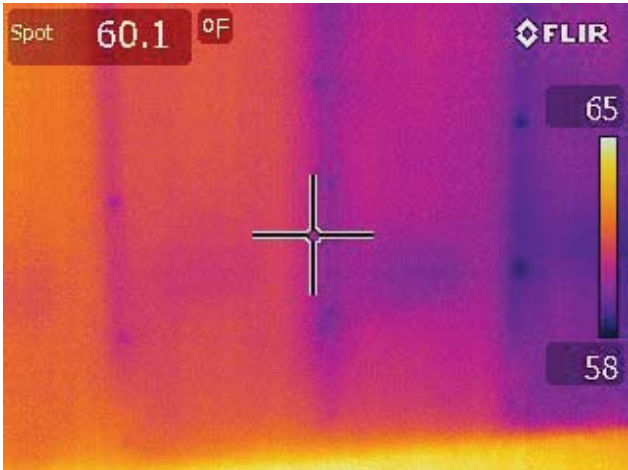
APPENDIX- 03c | METAL PANEL WALL SYSTEMS: Metal Panels with Continuous Metal Clips

Calculated Baseline R-Value:	19.77	-
As-Built Condition		
Thermal Image R-Value:	5.95	- 70 %
Simulated (THERM) R-Value:	9.70	- 51 %
Thermally Improved Condition		
See 3a	N/A	-

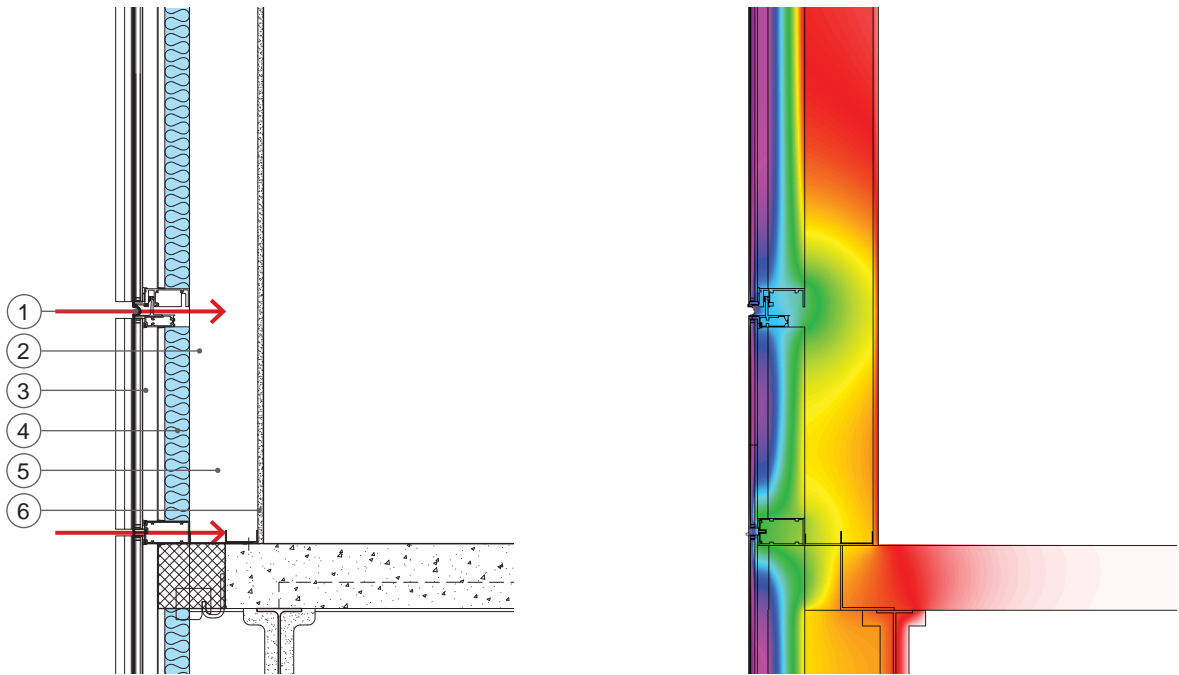
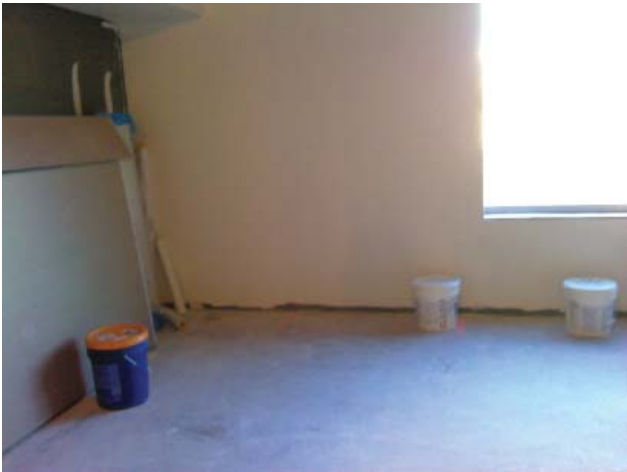
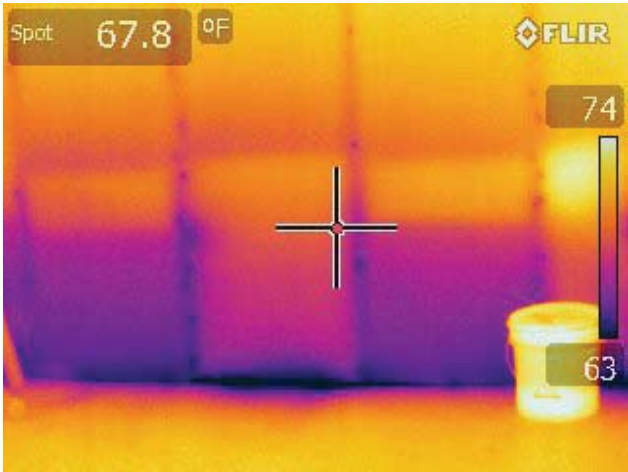
APPENDIX- 04a | CURTAIN WALLS: Insulation Between Mullions (Typical)

Calculated Baseline R-Value:	20.42	-
As-Built Condition		
Thermal Image R-Value:	5.75	- 72 %
Simulated (THERM) R-Value:	6.17	- 70 %
Thermally Improved Condition		
Simulated (THERM) R-Value:	NA

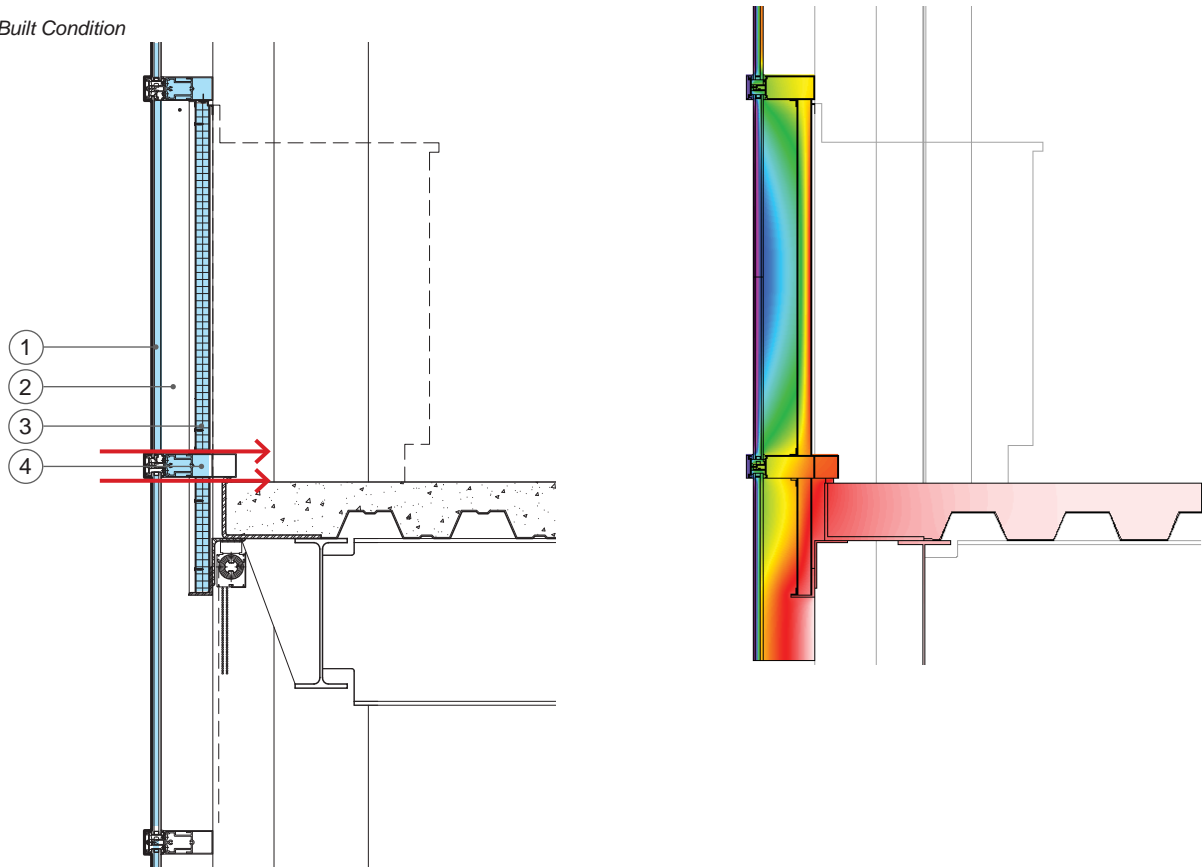
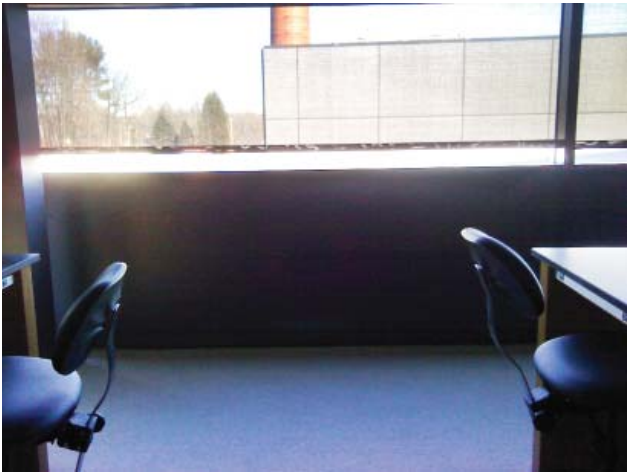
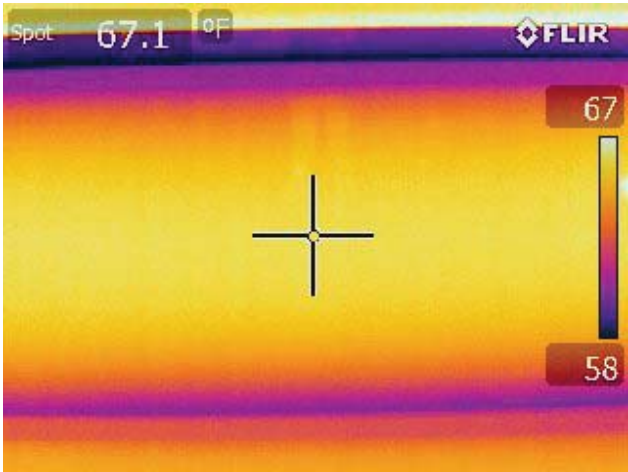
APPENDIX- 04b | CURTAIN WALLS: Insulation within Mullion

As-Built Condition
Thermal Image R-Value: 6.18 - 56 %
Simulated (THERM) R-Value: 4.92 - 62 %

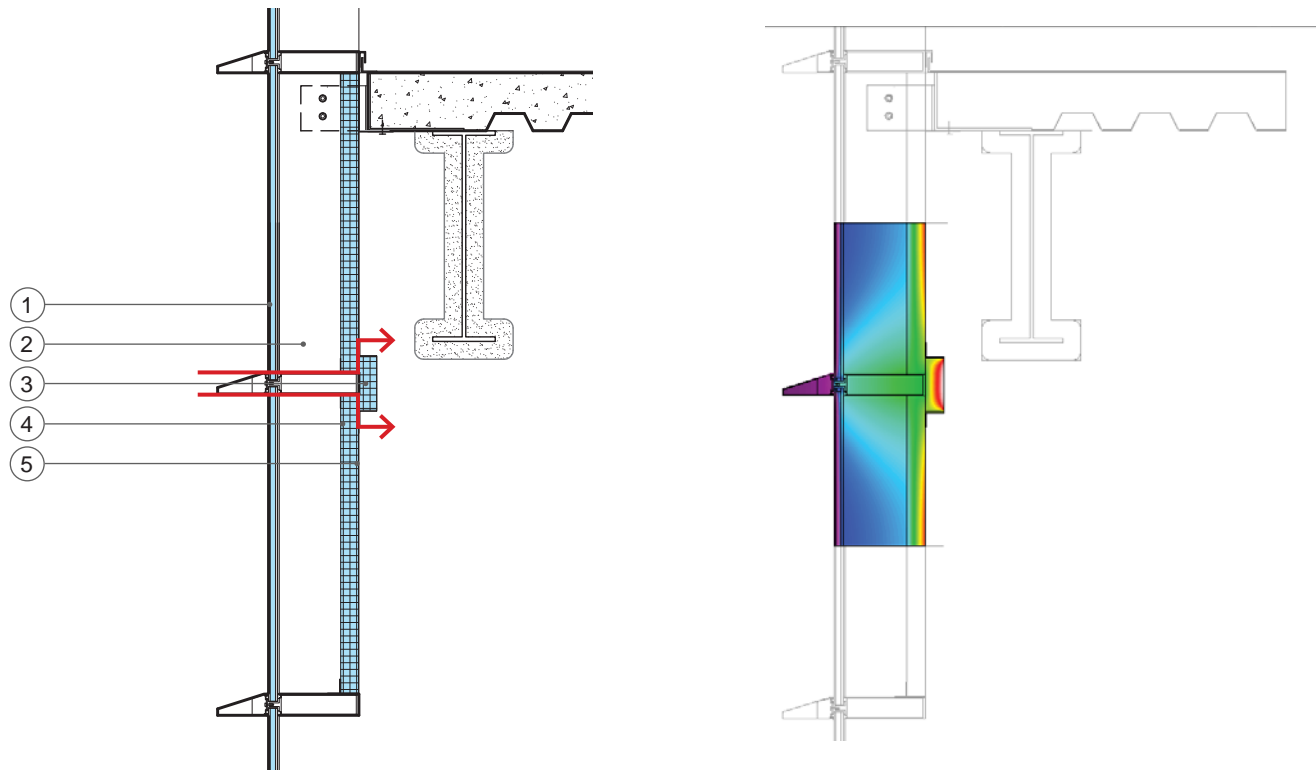
As-Built Condition
Thermal Image R-Value: NA
Simulated (THERM) R-Value: 5.11 - 61 %

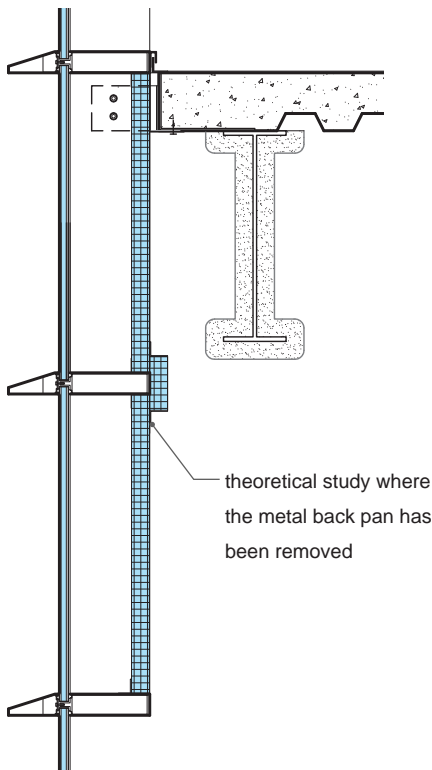
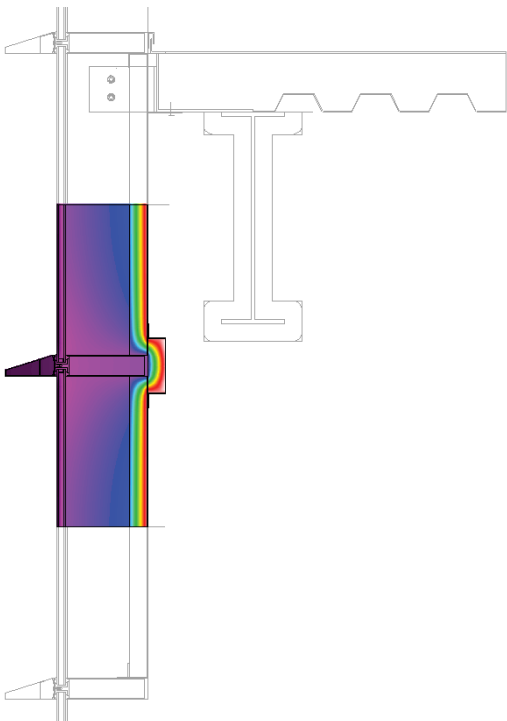
Thermally Improved Condition
Simulated (THERM) R-Value: 10.86 - 17 %

R-10.86
(+113%)

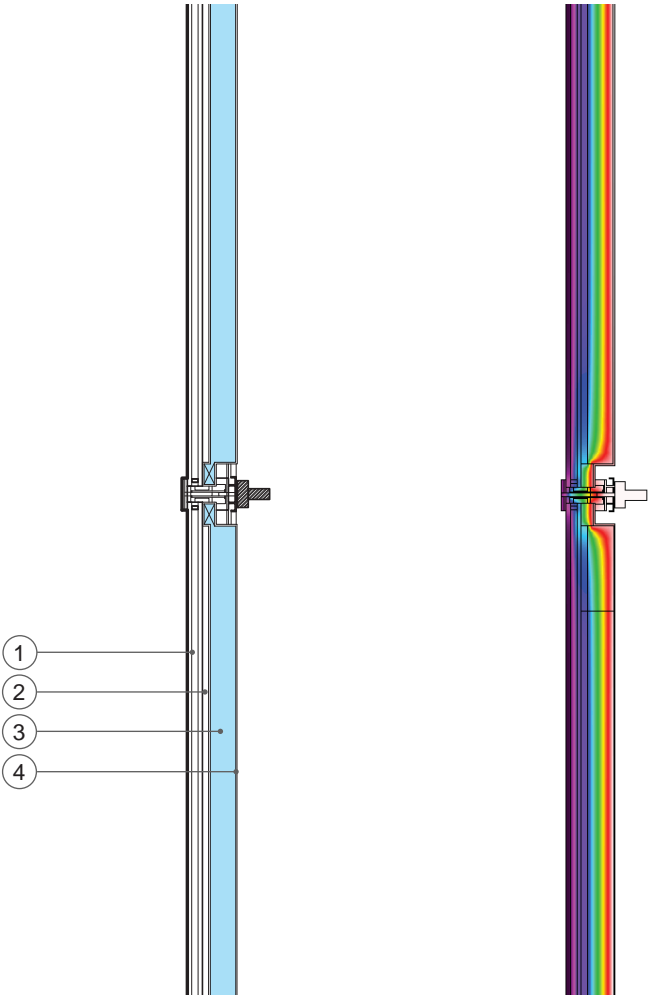
As-Built Condition
Thermal Image R-Value: NA
Simulated (THERM) R-Value: 8.09 - 31 %

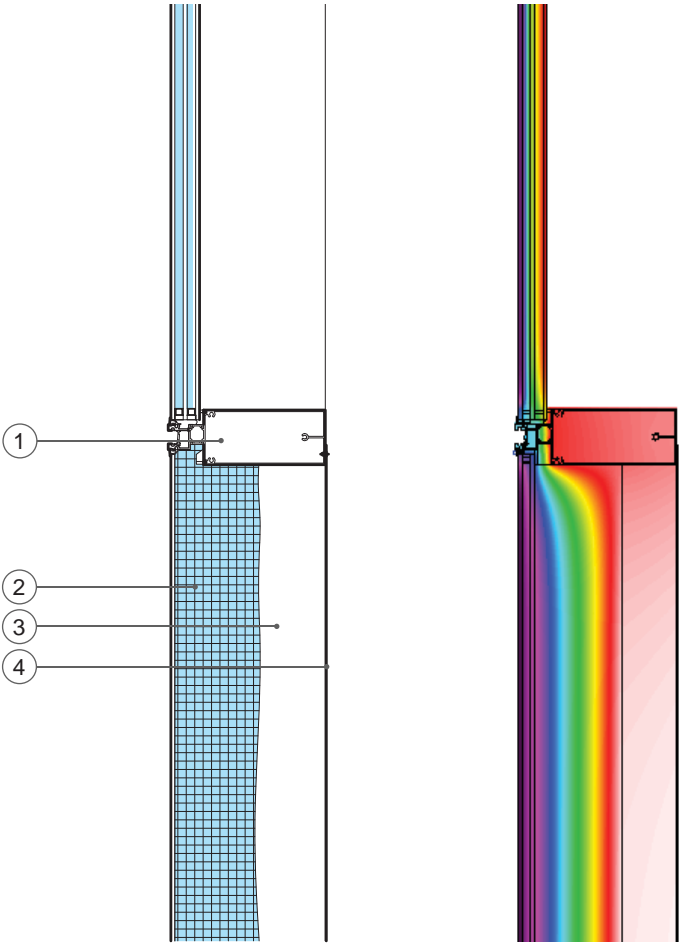
Calculated Baseline R-Value:	21.21	-
As-Built Condition		
Thermal Image R-Value:	N/A	N/A
Simulated (THERM) R-Value:	15.14	- 29 %
Thermally Improved Condition		
Simulated (THERM) R-Value:	N/A	N/A

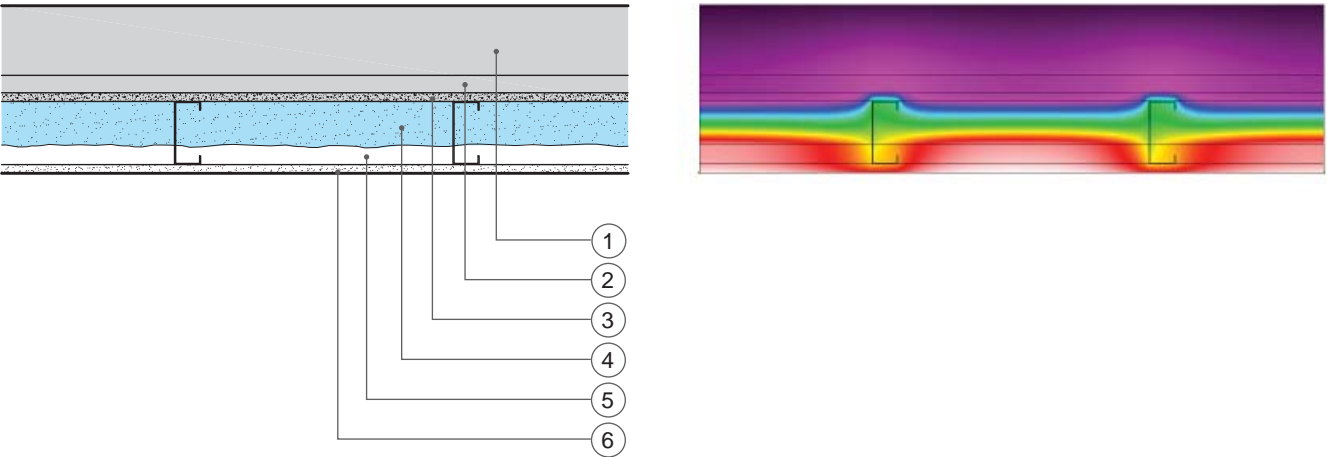
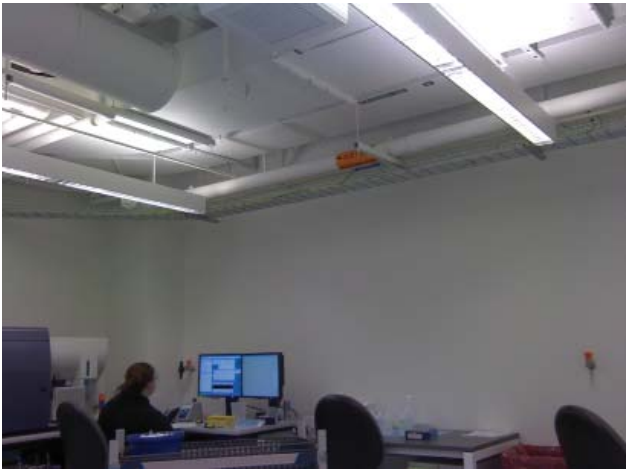
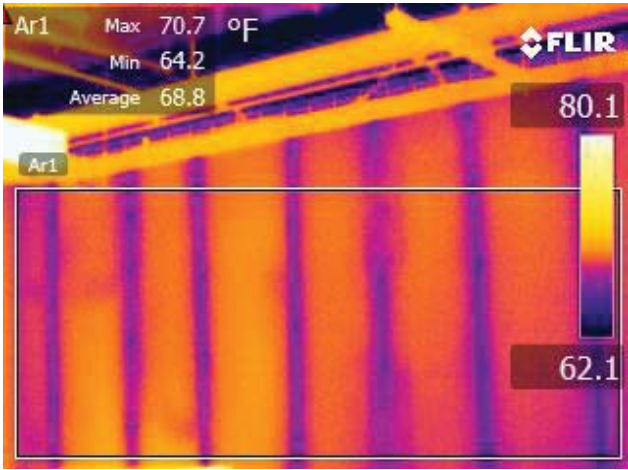
APPENDIX- 05a | INSULATING EXISTING BUILDINGS: Studs Directly Attached to Existing Wall

As-Built Condition
Thermal Image R-Value: 4.15 -78.9 %
Simulated (THERM) R-Value: 8.05 -58.9 %
