THERMAL PERFORMANCE OF FAÇADES

2012 AIA UPJOHN GRANT
RESEARCH INITIATIVE

Final Report | November 2014

PAYETTE **RESEARCH**

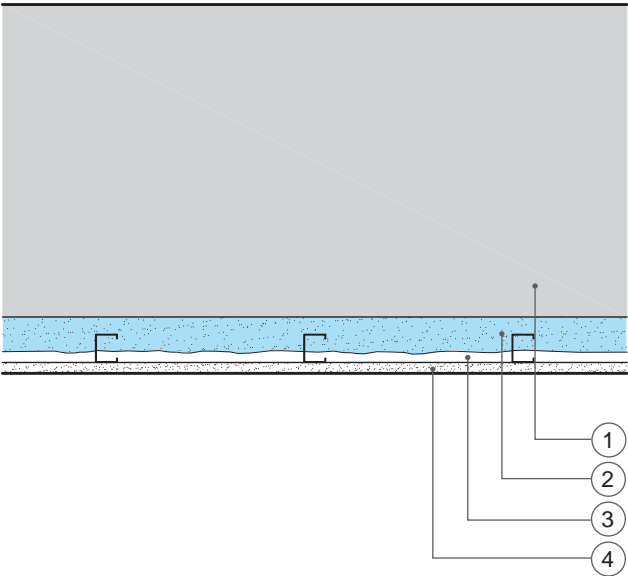
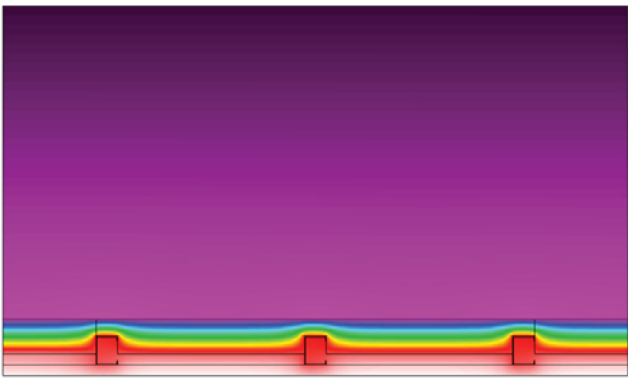
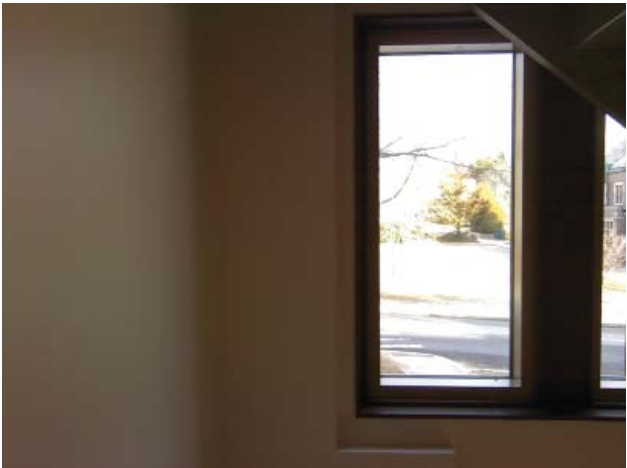
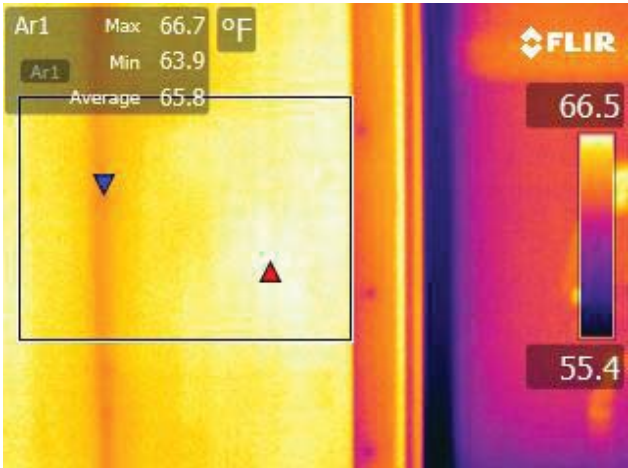
APPENDIX- 05b | INSULATING EXISTING BUILDINGS: Studs Pulled 1” Back From Existing Wall

Calculated Baseline R-Value:	16.84	-
As-Built Condition		
Thermal Image R-Value:	12.44	- 26 %
Simulated (THERM) R-Value:	14.11	- 16 %
Thermally Improved Condition		
See 05c

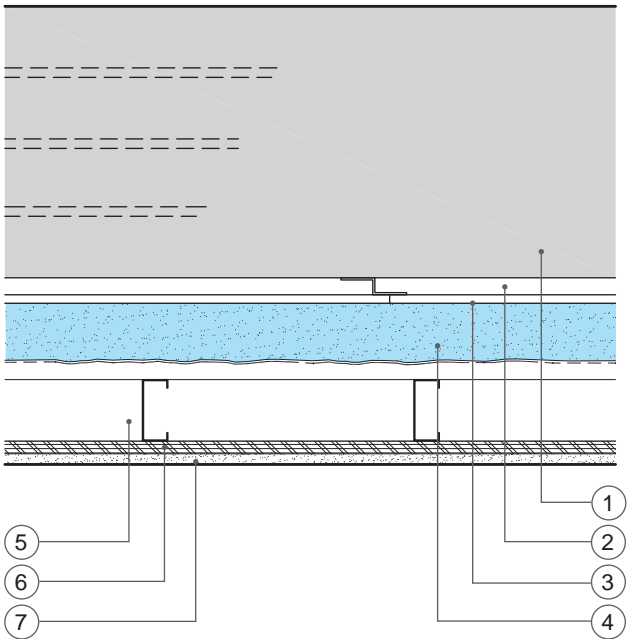
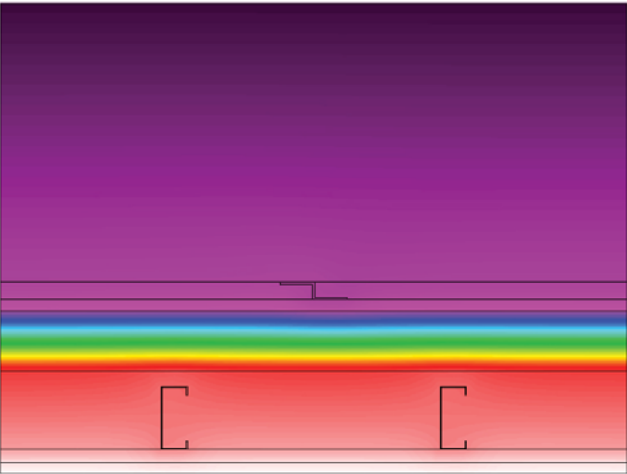
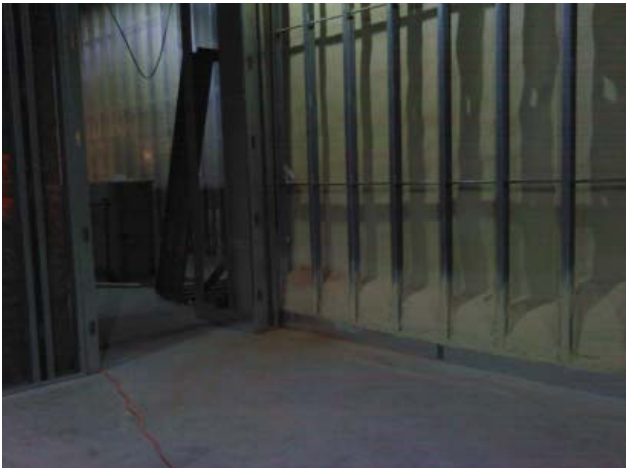
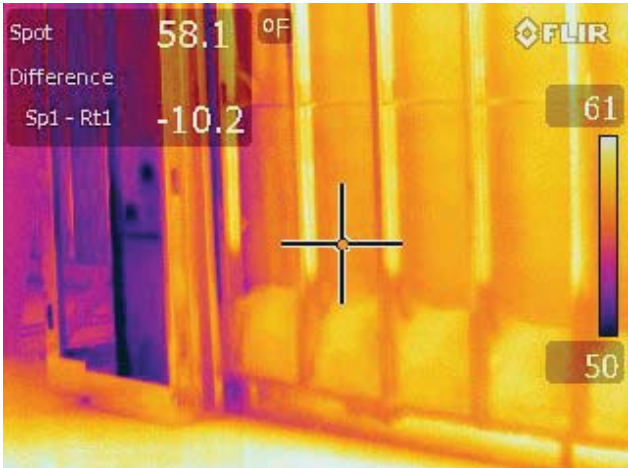
APPENDIX- 05c | INSULATING EXISTING BUILDINGS: Studs Separated From Insulation

Calculated Baseline R-Value:	29.23	-
As-Built Condition		
Thermal Image R-Value:	20.16	- 31 %
Simulated (THERM) R-Value:	28.78	- 1.5 %
Thermally Improved Condition		
N/A		-

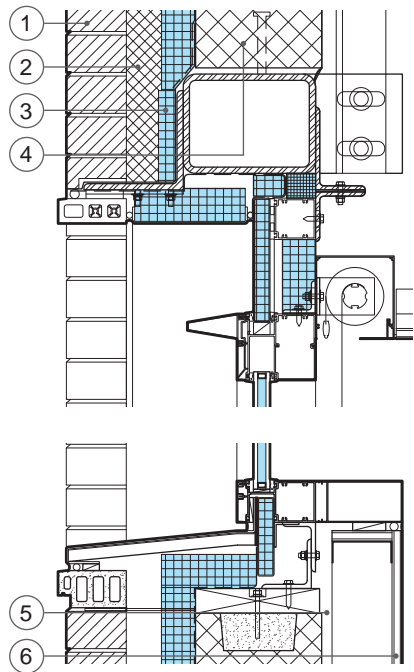
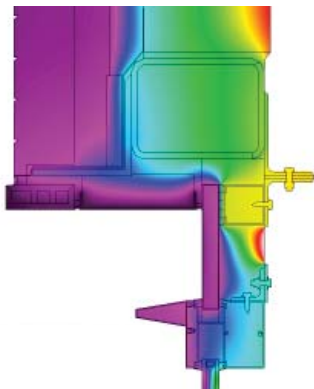
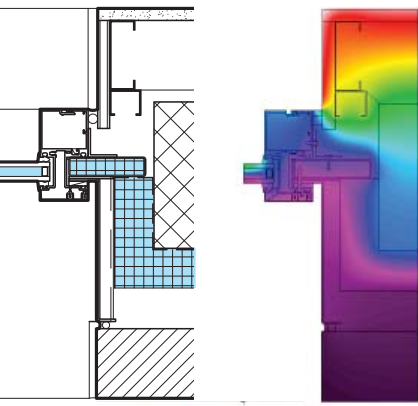
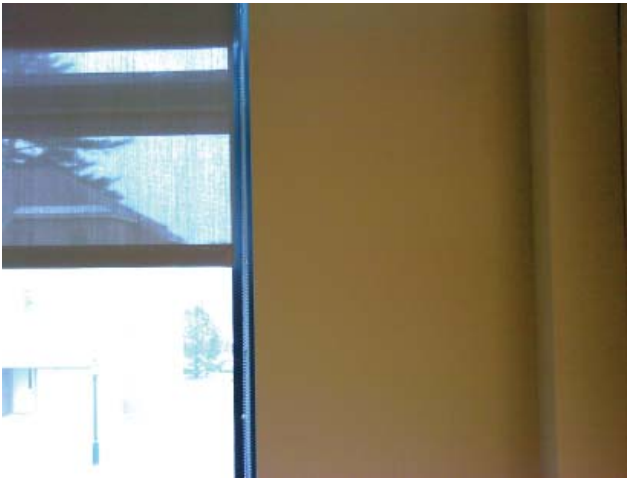
APPENDIX- 06a | WINDOW TRANSITIONS: Recessed Relationship with Thermal Barrier

As-Built Condition
Thermal Image R-Value: 6.58 - 57 %
Simulated (THERM) R-Value:
Head 6.46 - 58 %
Jamb 6.58 - 51 %
Sill 4.60 - 70 %

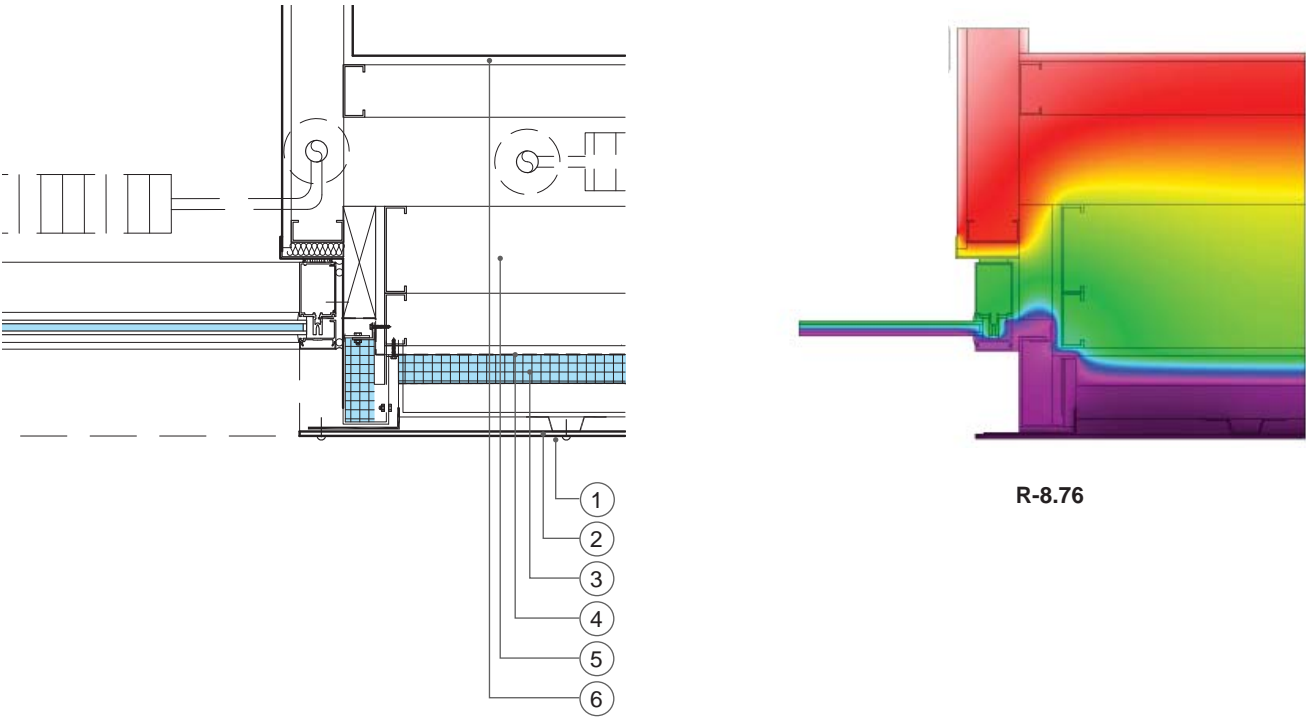
As-Built Condition
Thermal Image R-Value: N/A
Simulated (THERM) R-Value: 8.76 - 37 %

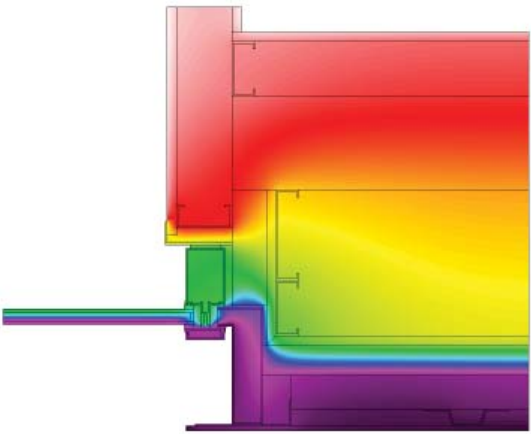
R-11.16
(+27%)

Thermally Improved Condition
Simulated (THERM) R-Value: 11.16 - 19 %

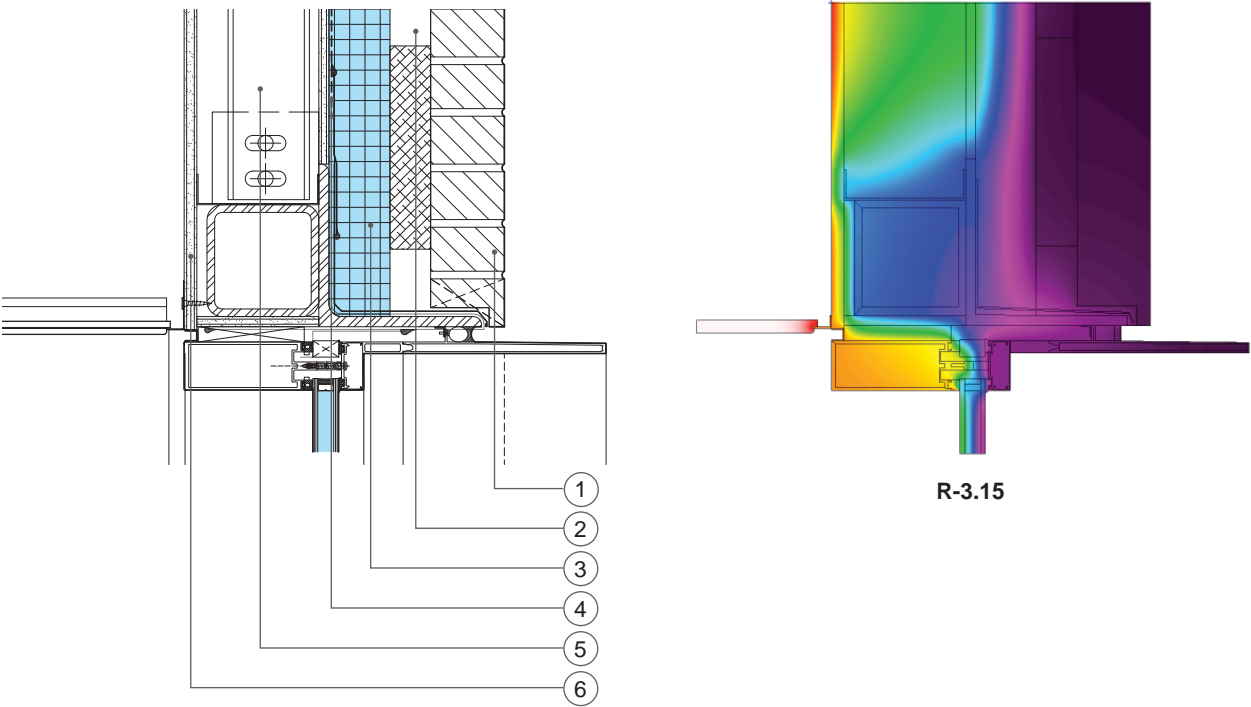
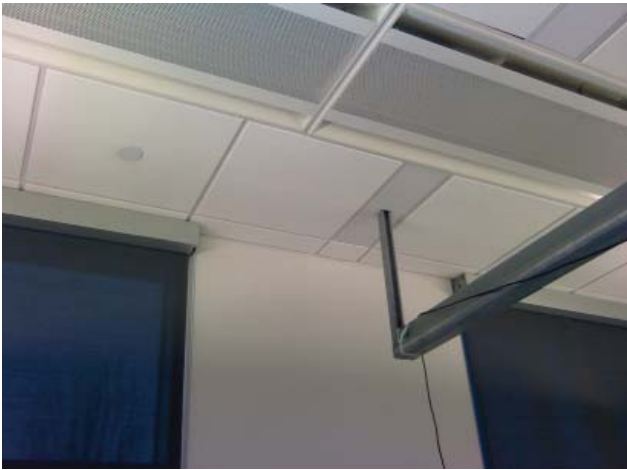
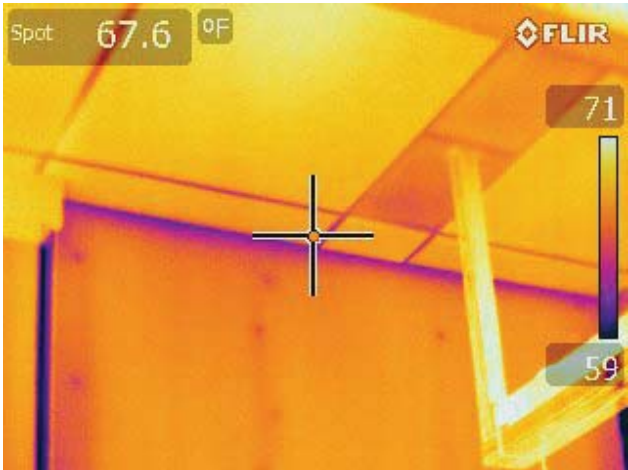
Calculated Baseline R-Value:	19.82	-
As-Built Condition		
Thermal Image R-Value:	8.91	- 55 %
Simulated (THERM) R-Value:	3.15	- 84 %
Thermally Improved Condition		
Simulated (THERM) R-Value:	7.08	- 64 %

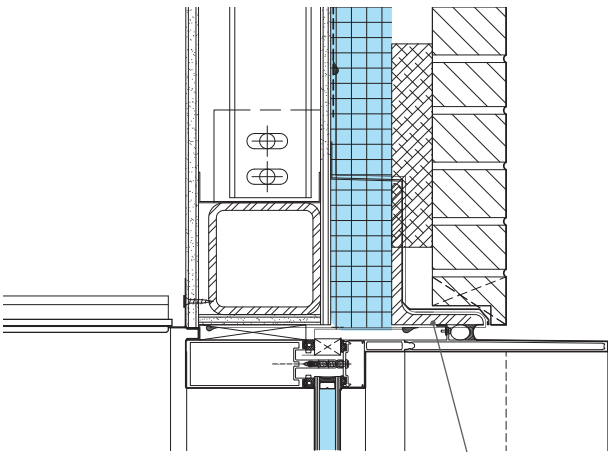
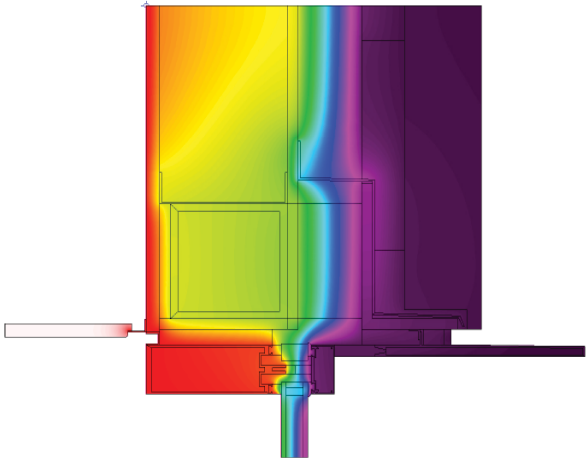
Thermally Improved Condition

R-7.08
(+125%)

brick lintel pulled outside of insulation with intermittent bracing back to structural steel tube

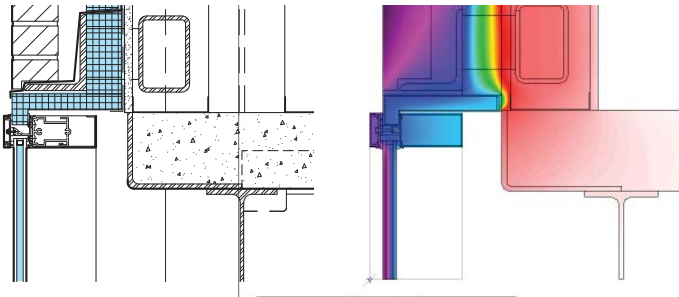
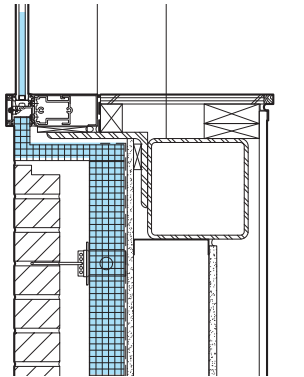
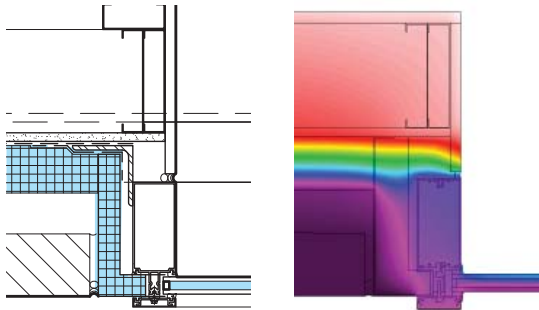
Thermally Improved Condition

frame R-4.02
(+41%)

frame R-4.28
(+44%)

frame R-3.46
(+38%)

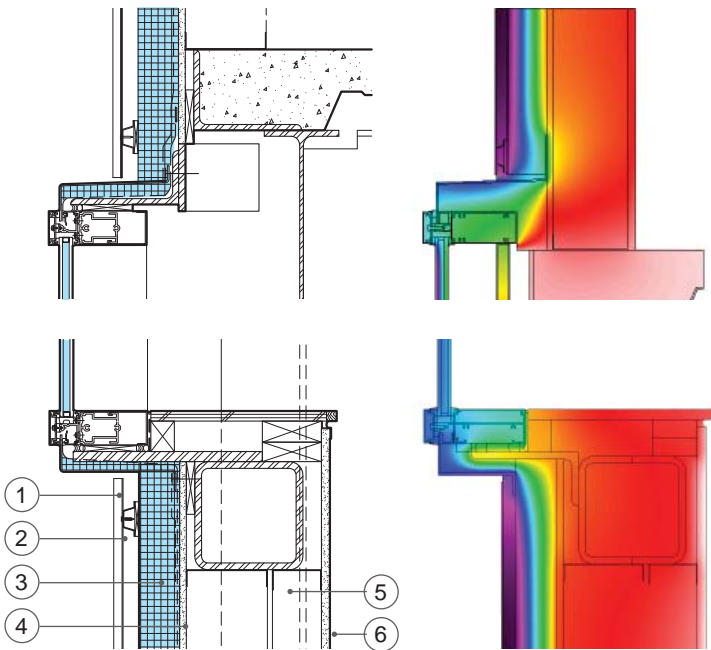
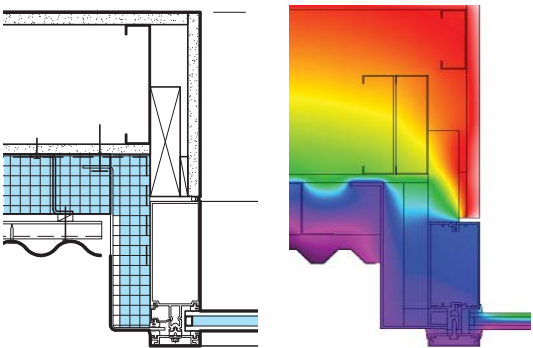
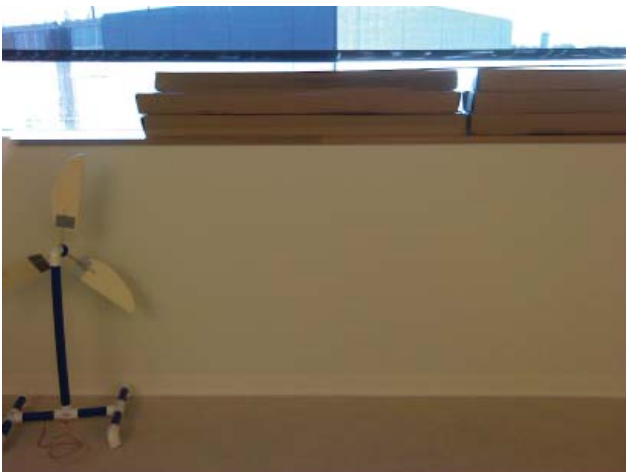
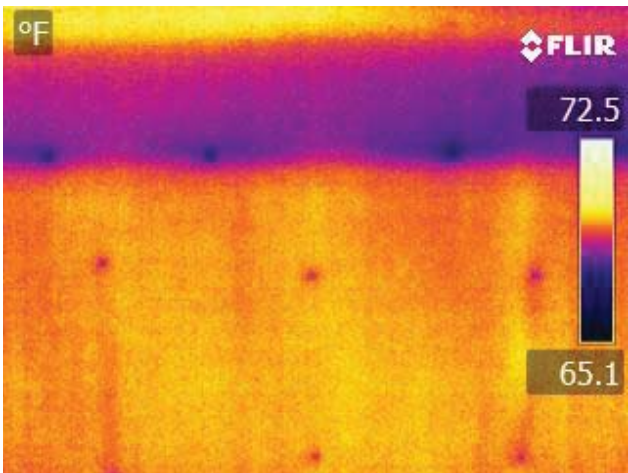
Project Conditions		Summary of Thermal Performance		
Location:	Southeastern Massachusetts	Calculated Baseline R-Value:	18.78	-
Date of Thermal Image:	02/09/2012	As-Built Condition		
Exterior Air Temperature:	37.7 °F	Thermal Image R-Value:	8.58	- 54 %
Interior Air Temperature:	71.7 °F	Simulated (THERM) R-Value:		
Radiant Temperature:	72.9 °F	Head	10.48	- 44 %
Assumed Emissivity:	0.9	Jamb	9.36	- 50 %
		Sill	10.39	- 45 %

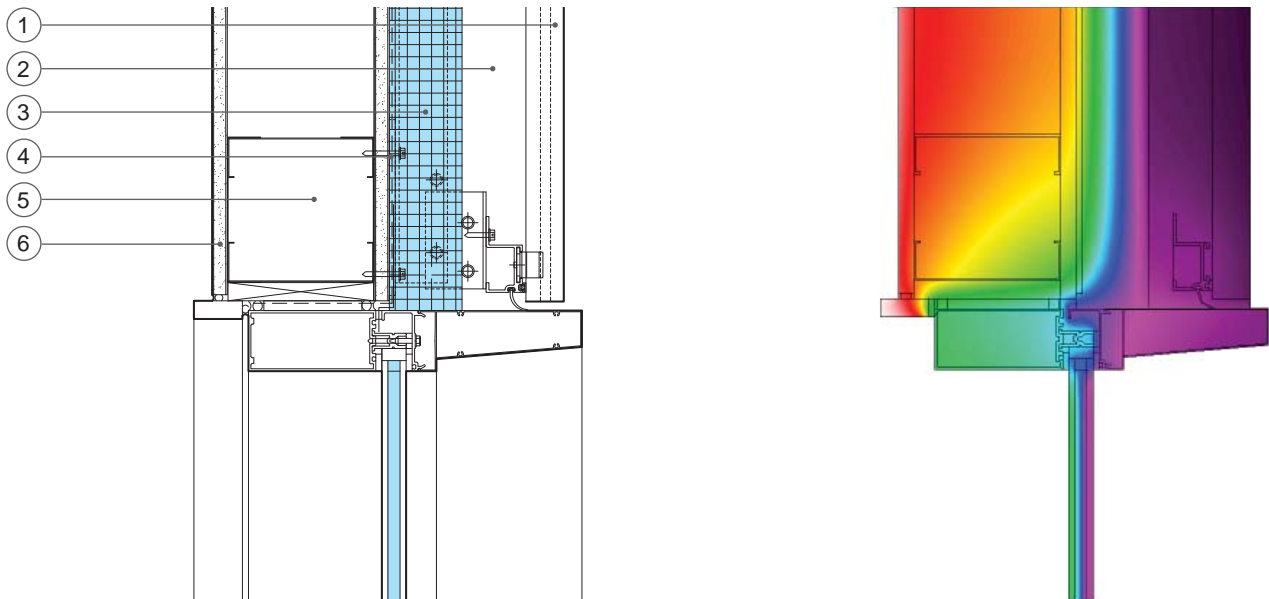
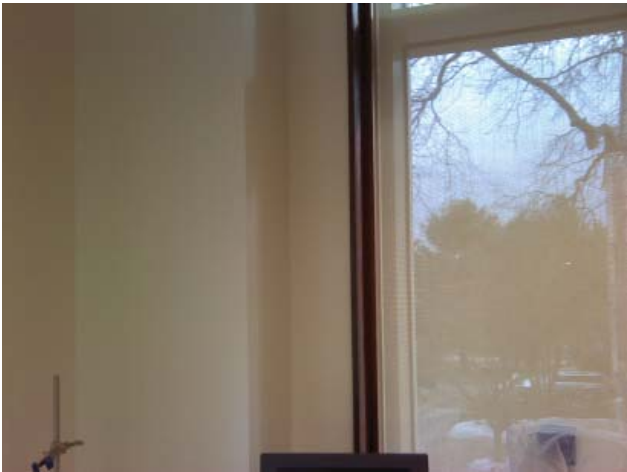
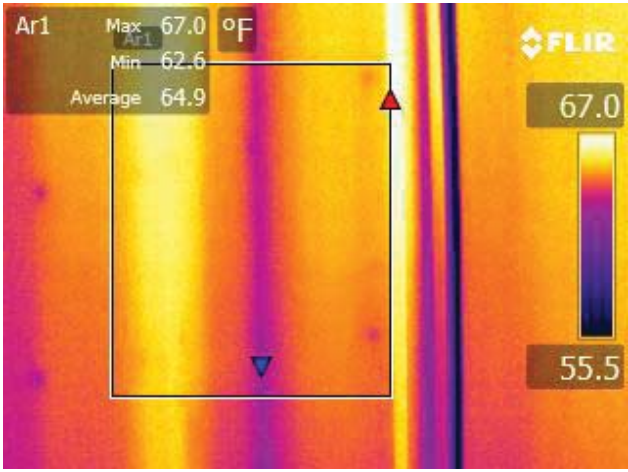
As-Built Condition
Thermal Image R-Value: 7.94 - 62 %
Simulated (THERM) R-Value: 7.12 - 66 %

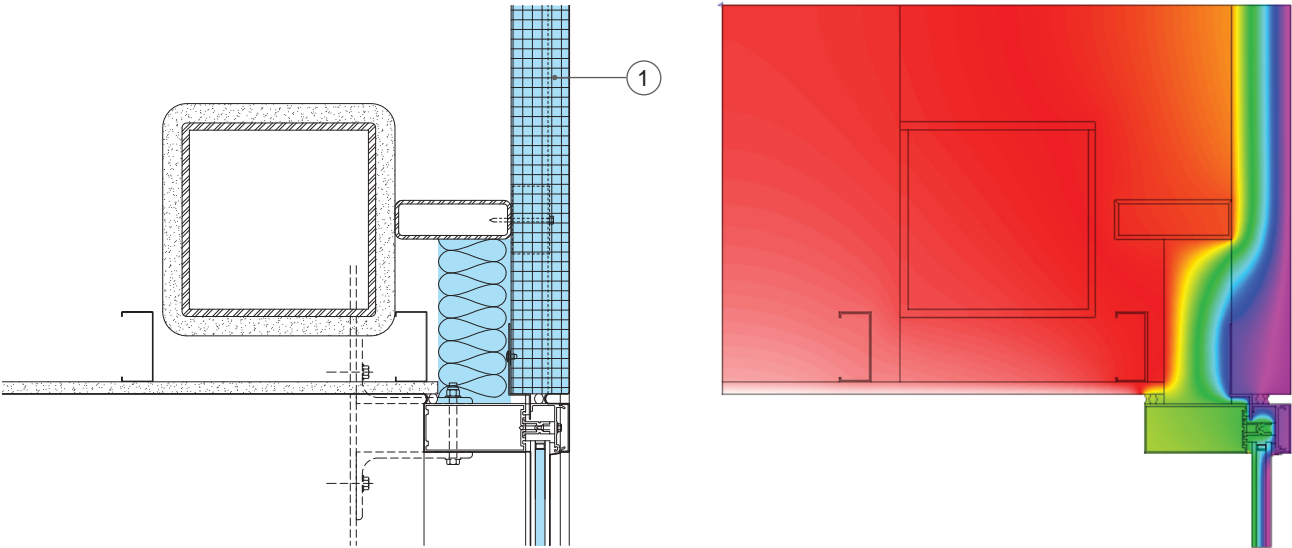
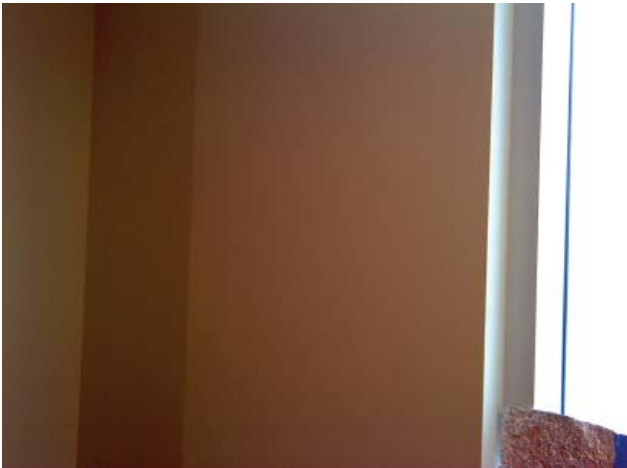
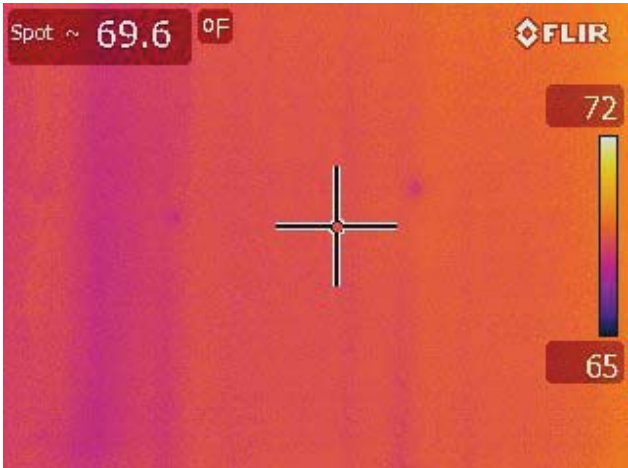
As-Built Condition

Thermal Image R-Value: 9.14 - 60 %
Simulated (THERM) R-Value: 9.57 - 58 %

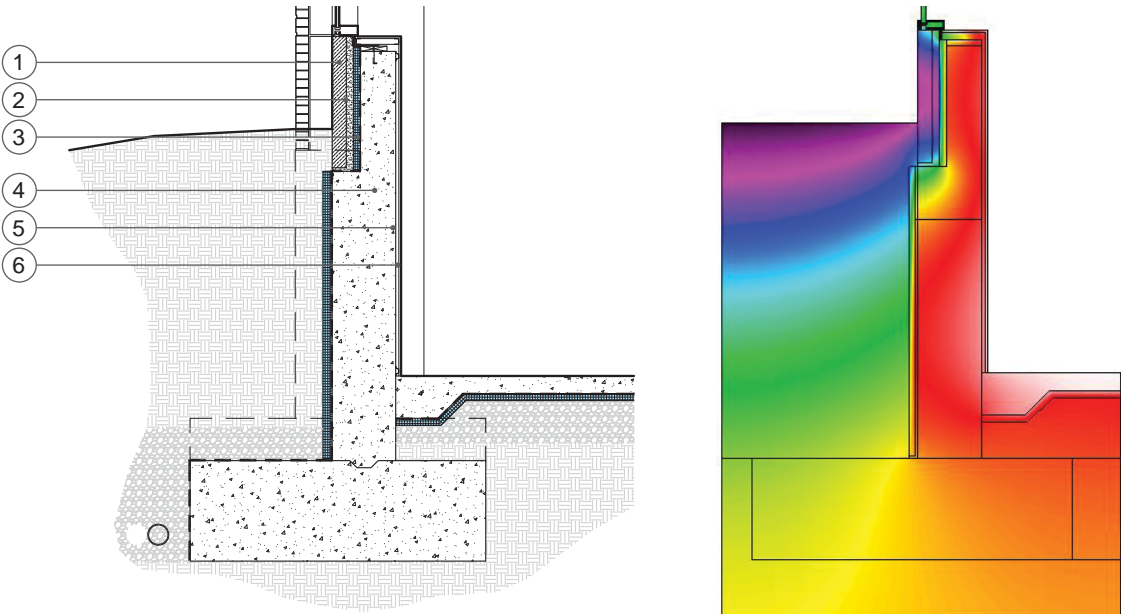
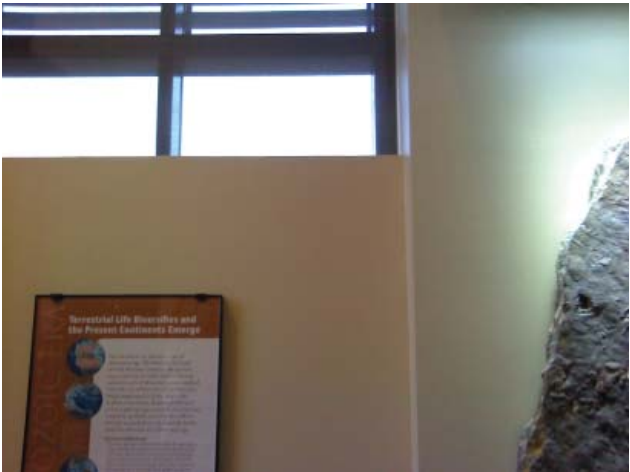
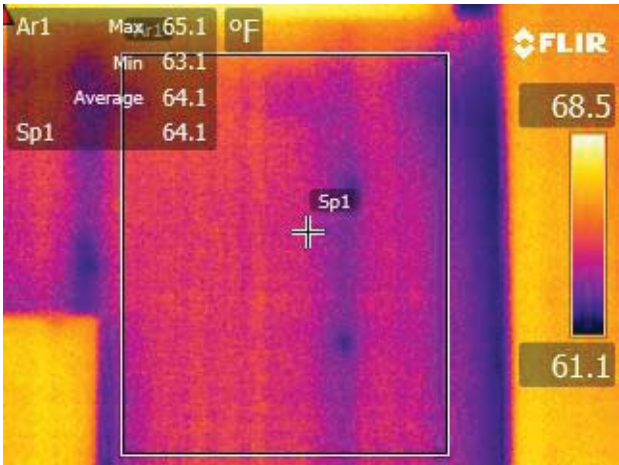
Calculated Baseline R-Value:	14.01	-
As-Built Condition		
Thermal Image R-Value:	3.71	- 74 %
Simulated (THERM) R-Value (wall):	8.39	- 40 %
Simulated (THERM) R-Value (floor):	26.8	-
Thermally Improved Condition		
Simulated (THERM) R-Value:	N/A	N/A

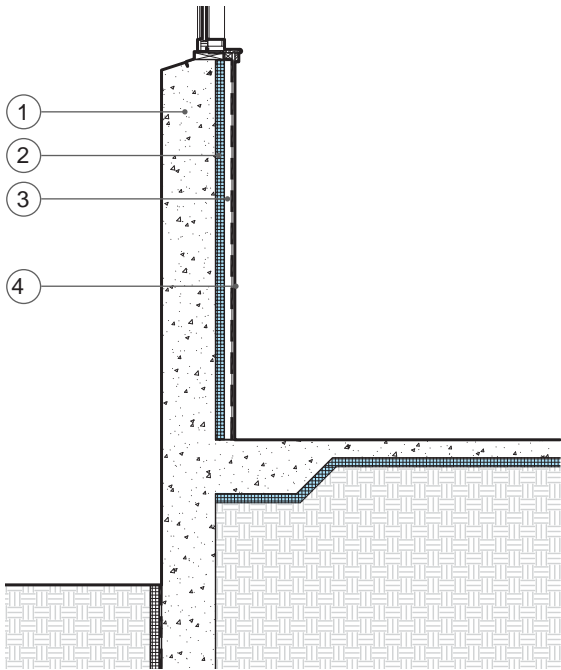
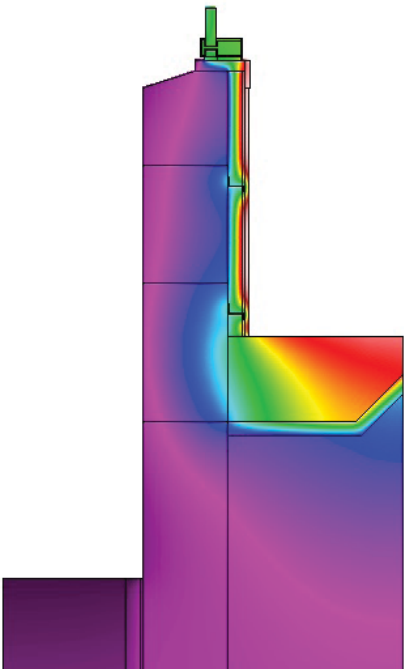
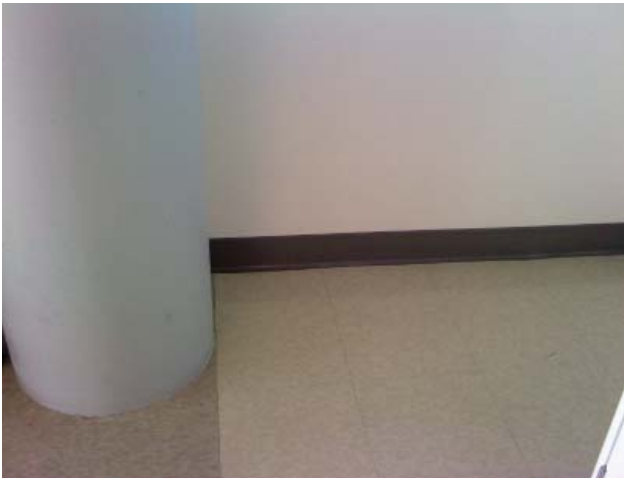
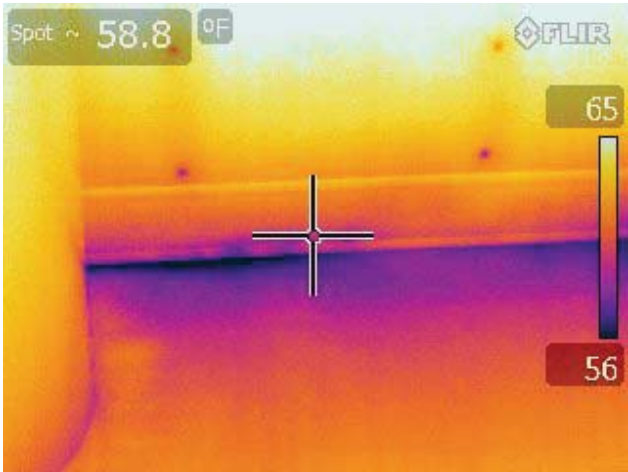
Calculated Baseline R-Value:	13.74	-
As-Built Condition		
Thermal Image R-Value:	3.5	- 74.5 %
Simulated (THERM) R-Value (wall):	5.8	- 57.8 %
Simulated (THERM) R-Value (floor):	3.2	-
Thermally Improved Condition		
Simulated (THERM) R-Value (wall):	6.1	-55.6 %
Simulated (THERM) R-Value (floor):	5.85	-

R-5.8 (wall), R-3.2 (floor)

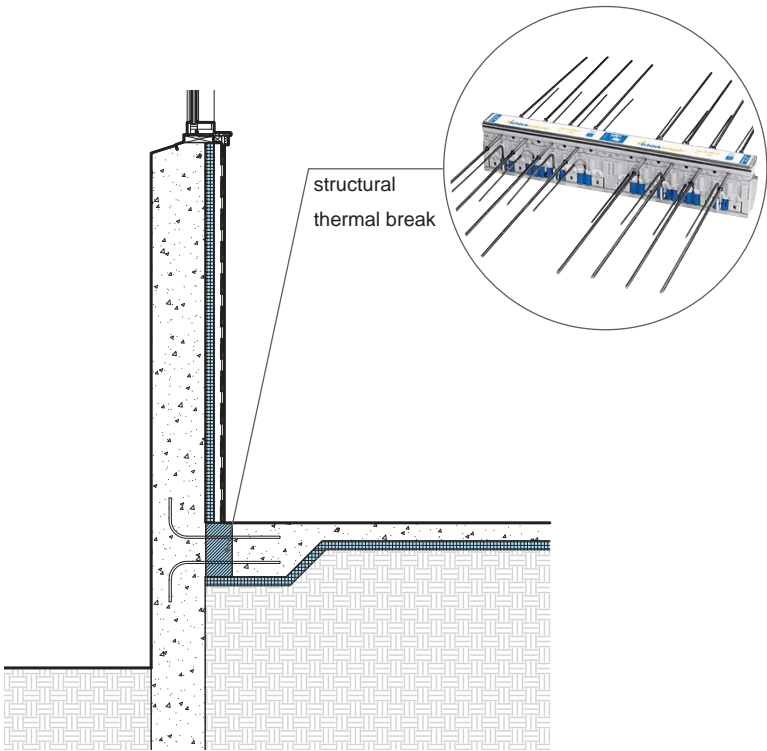
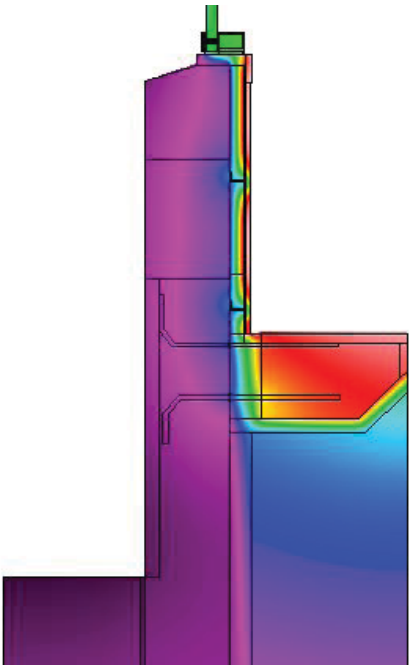
Thermally Improved Condition

R-6.1 (wall), R-5.85 (floor)
(+5% wall, +82.8% floor)

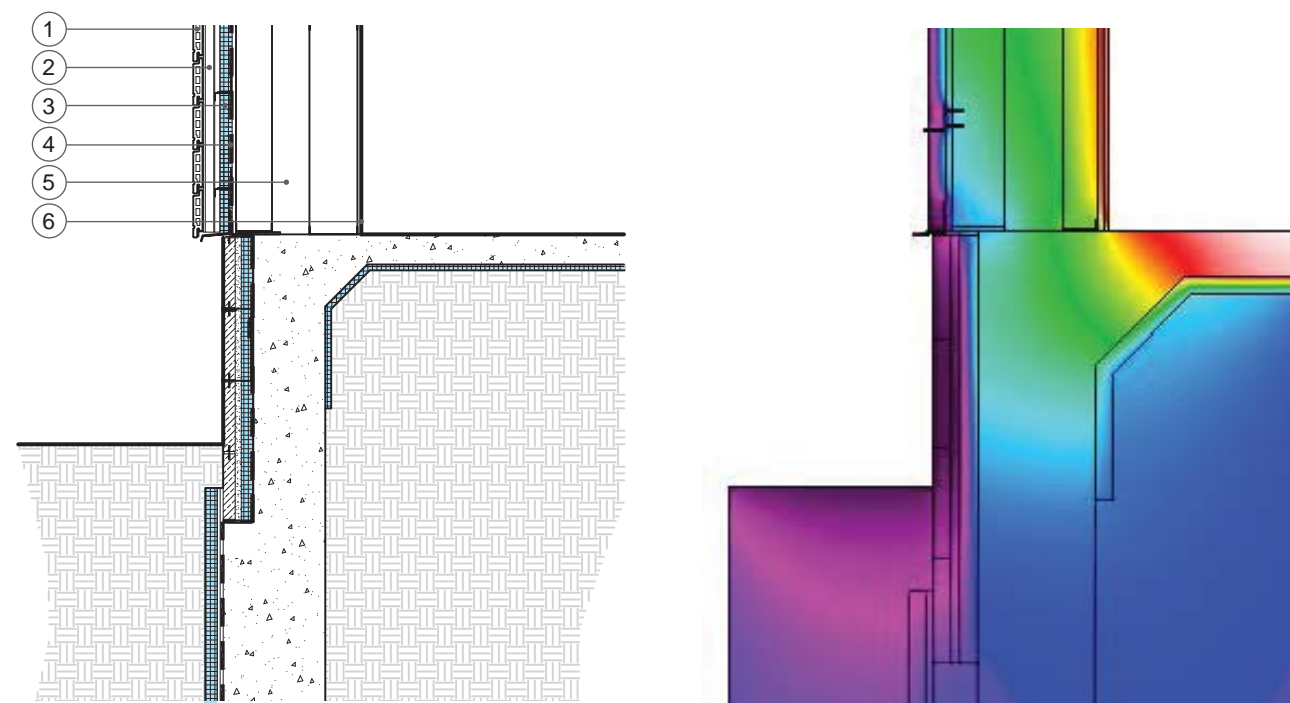
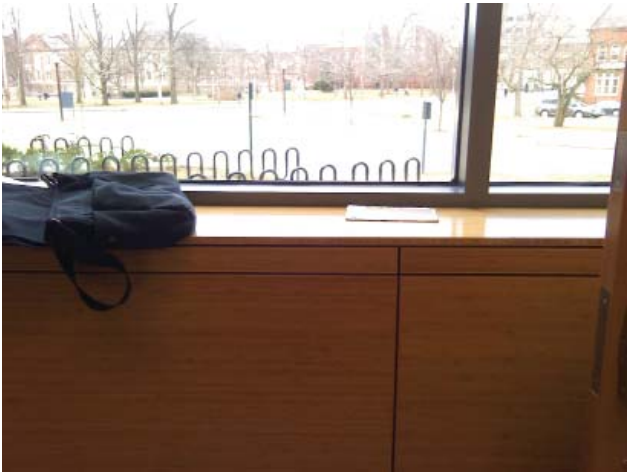
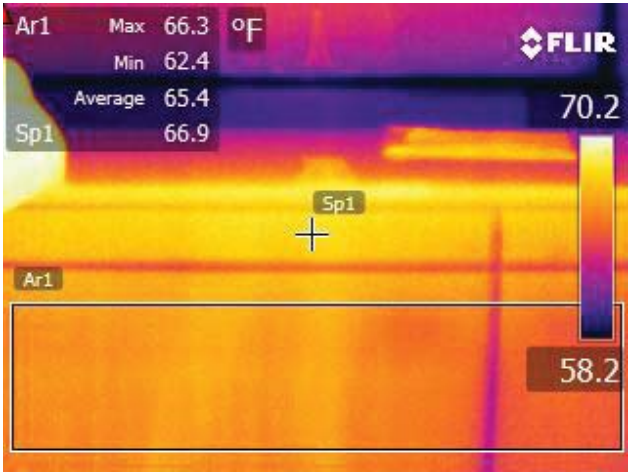
Calculated Baseline R-Value:	13.86	-
As-Built Condition		
Thermal Image R-Value:	4.13	- 70 %
Simulated (THERM) R-Value (wall):	5.94	- 57 %
Simulated (THERM) R-Value (floor):	5.01	-
Thermally Improved Condition		
Simulated (THERM) R-Value:	N/A	N/A

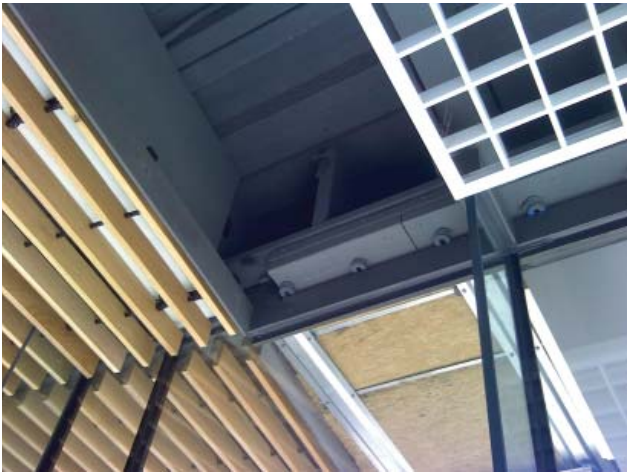
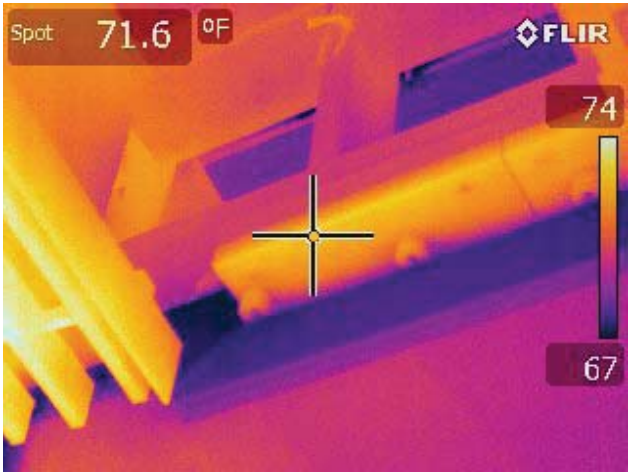
Digital Image

Calculated Baseline R-Value:	19.14	-
As-Built Condition		
Thermal Image R-Value:	N/A	-
Simulated (THERM) R-Value:	17.2	- 10 %
Thermally Improved Condition		
Simulated (THERM) R-Value:	28.3	+48 %

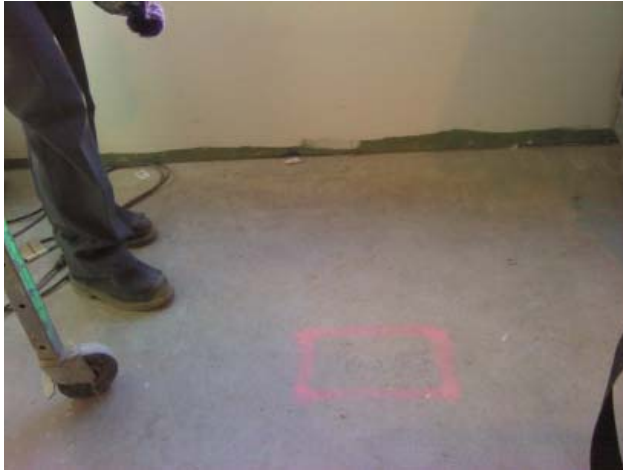
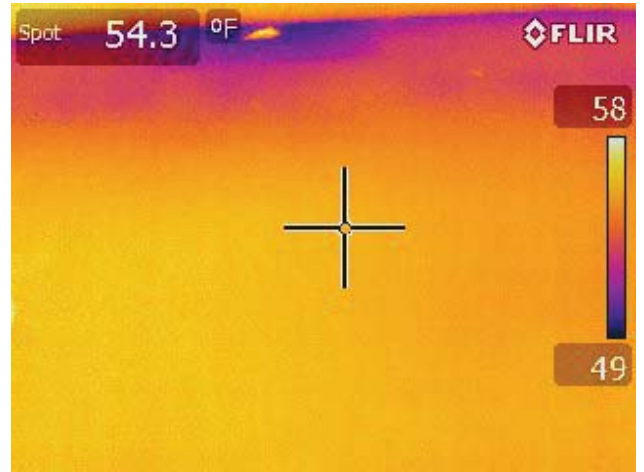
APPENDIX- 09b | SOFFITS: Soffit at Metal Panel Wall

As-Built Condition
Thermal Image R-Value: 2.28 - 84 %
Simulated (THERM) R-Value: 15.6 +12.7 %

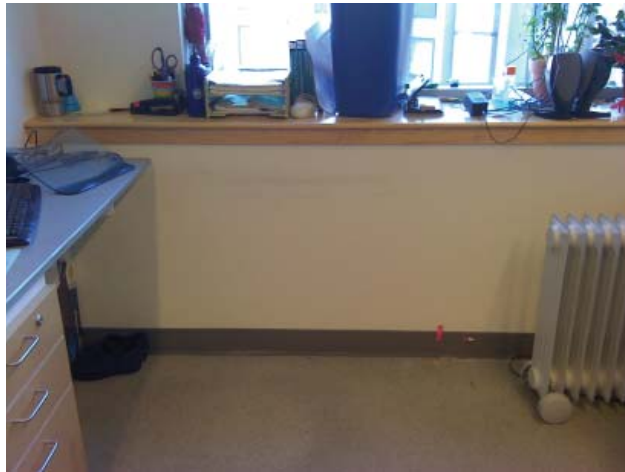
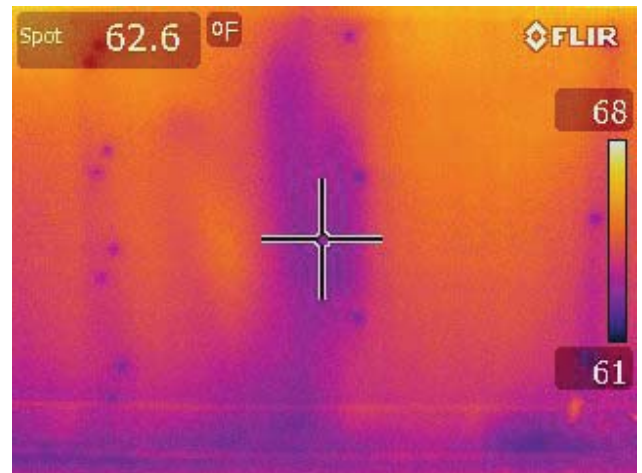
APPENDIX- 10a | ROOF TO WALL TRANSITIONS: Stud Back Up Wall with Insulation and Blocking

Calculated Baseline R-Value:	13.86	-
As-Built Condition		
Thermal Image R-Value:	3.88	- 75 %
Simulated (THERM) R-Value:	6.40	- 54 %
Thermally Improved Condition		
Simulated (THERM) R-Value:	N/A	N/A

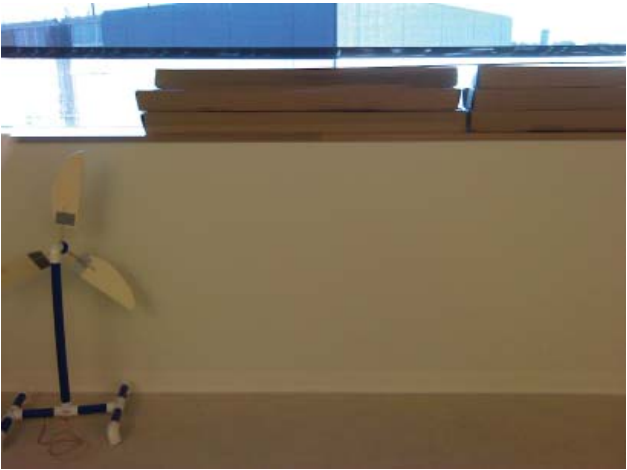
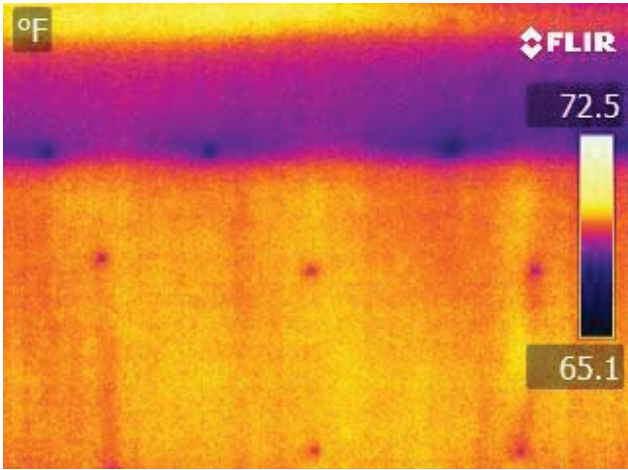
APPENDIX- 10b | ROOF TO WALL TRANSITIONS: Stud Back Up Wall with Continuous Insulation

Calculated Baseline R-Value:	16.74	-
As-Built Condition		
Thermal Image R-Value:	8.2	- 49 %
Simulated (THERM) R-Value:	14	- 14 %
Thermally Improved Condition		
Simulated (THERM) R-Value:	N/A	-

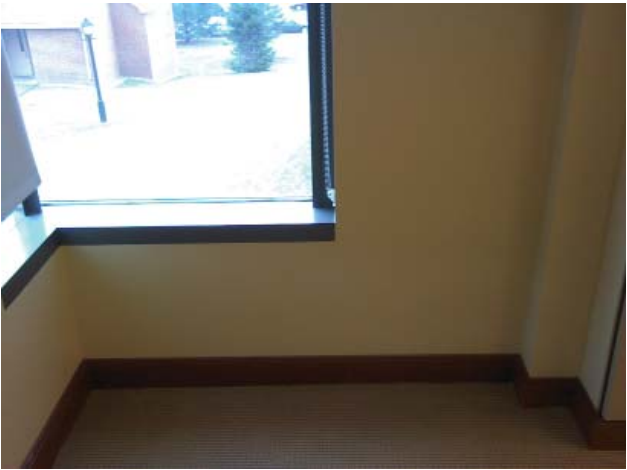
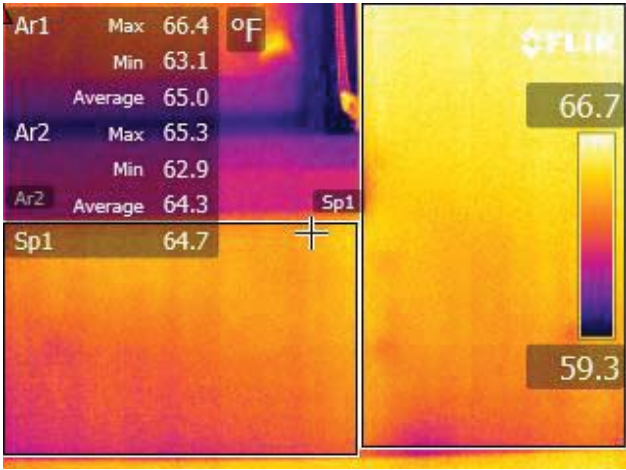
APPENDIX- 10c | ROOF TO WALL TRANSITIONS: CMU Back Up with Continuous Insulation

Calculated Baseline R-Value:	15.42	-
As-Built Condition		
Thermal Image R-Value:	5.5	- 64 %
Simulated (THERM) R-Value:	5.5	- 64 %
Thermally Improved Condition		
Simulated (THERM) R-Value:	N/A	N/A

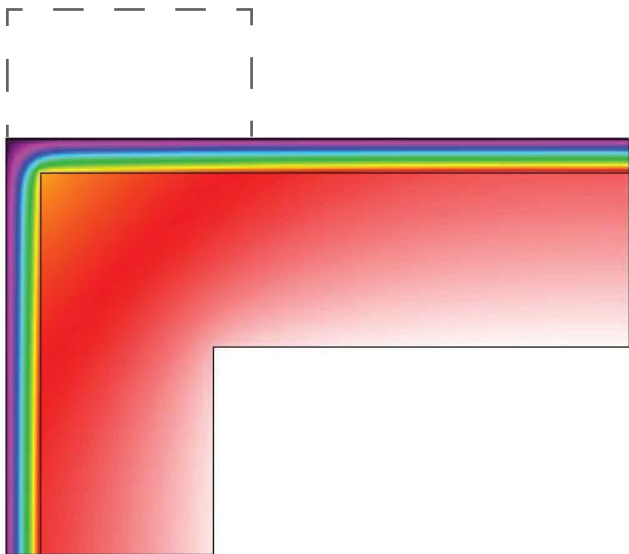
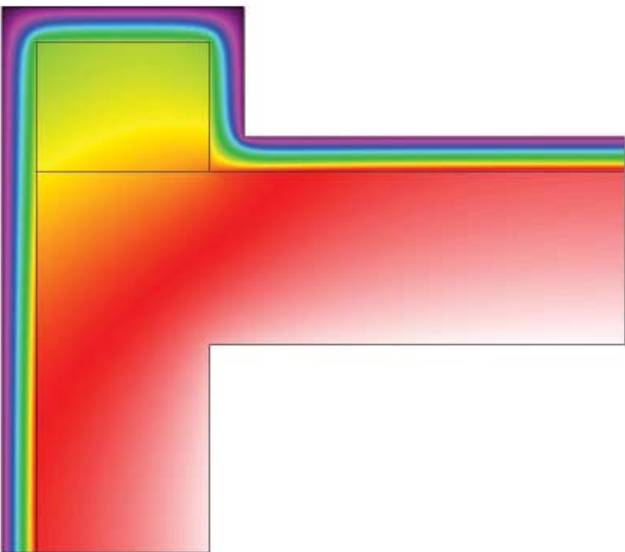
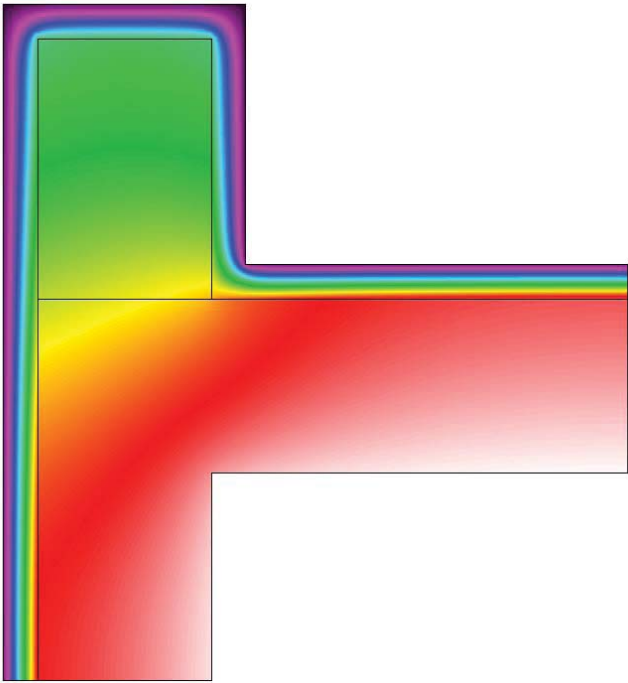
Simulated Baseline R-Value: (insulating beneath the parapet)	15.33	-
Simulated 1'-3" tall parapet R-Value:	13.42	- 12.5 %
Simulated 2'-6" tall parapet R-Value:	12.25	- 20.1 %
Simulated 5'-0" tall parapet R-Value:	11.27	- 26.5 %

R-15.33
Insulating beneath parapet

R-13.42
Insulating around 1'-3" tall parapet

R-12.25
Insulating around 2'-6" tall parapet

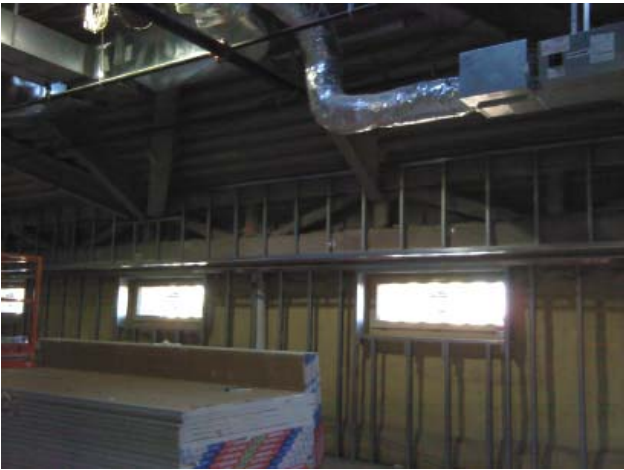
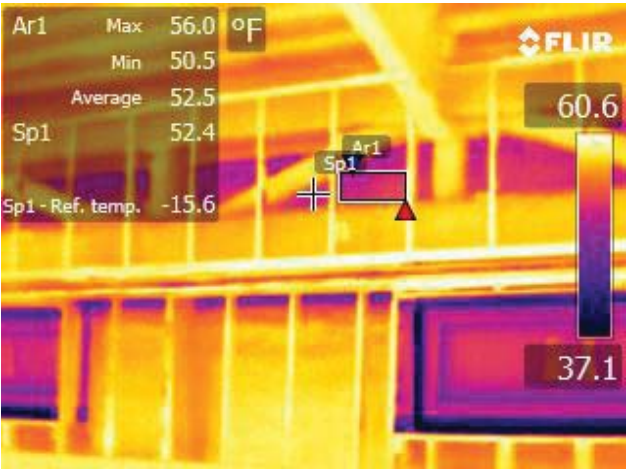
APPENDIX- 12a | ROOF PENETRATIONS: Roof Davits

Calculated Baseline R-Value:	17.75	-
As-Built Condition		
Thermal Image R-Value:	5.76	- 67 %
Simulated (THERM) R-Value:	10.07	- 43 %
Thermally Improved Condition		
Simulated (THERM) R-Value:	N/A	N/A

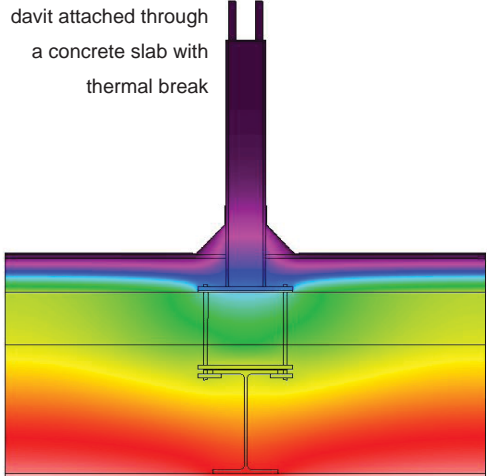
davit attached through a concrete slab with thermal break

+ 23.5%

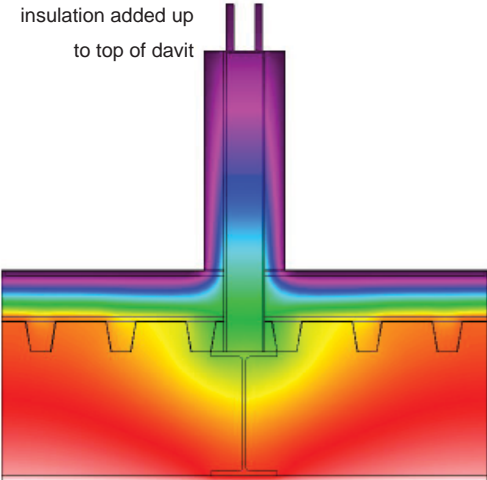
insulation added up to top of davit

+ 30.9%

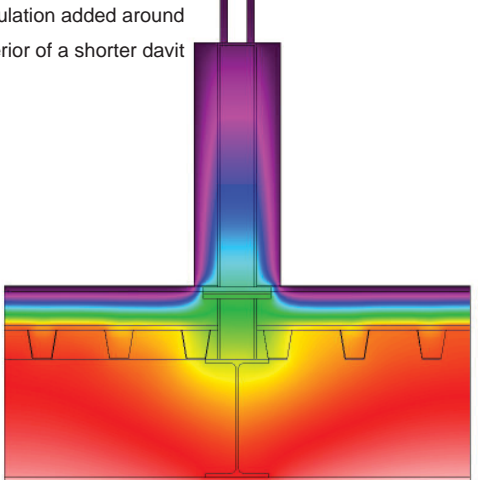
insulation added around exterior of a shorter davit

+ 53.9%

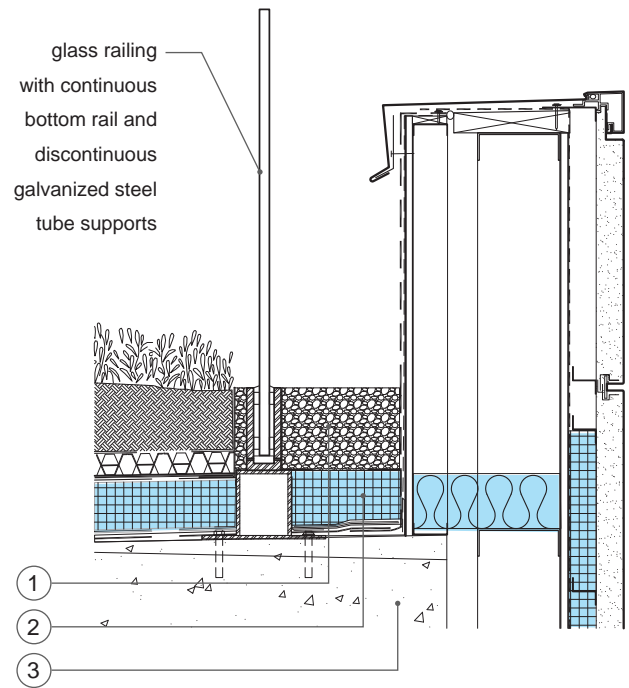
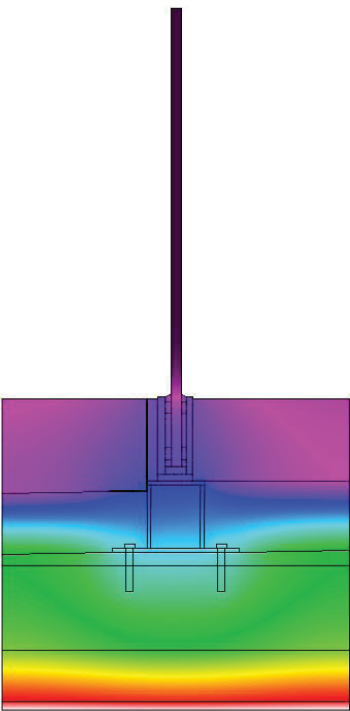
Calculated Baseline R-Value:	24.02	-
As-Built Condition		
Thermal Image R-Value:	-	-
Simulated (THERM) R-Value:	4.75	-80 %
Thermally Improved Condition		
Simulated (THERM) R-Value:	7.75	- 67.7 %

R-4.75
