THERMAL PERFORMANCE OF FAÇADES

2012 AIA UPJOHN GRANT
RESEARCH INITIATIVE

Final Report | November 2014

PAYETTE **RESEARCH**

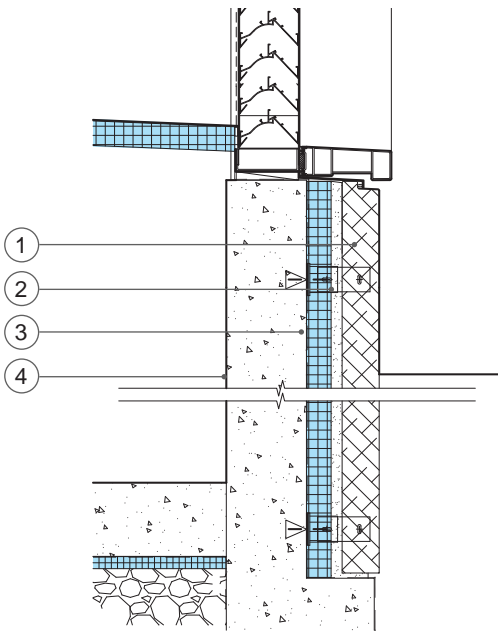
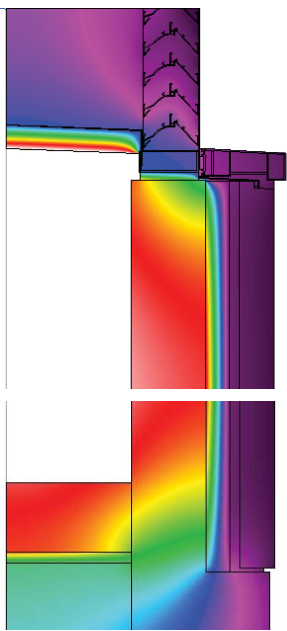
Calculated Baseline R-Value:	11.49	-
As-Built Condition		
Simulated (THERM) R-Value:	5.68	- 58 %
Thermally Improved Condition		
Simulated (THERM) R-Value:	6.53	- 52 %

R-5.68

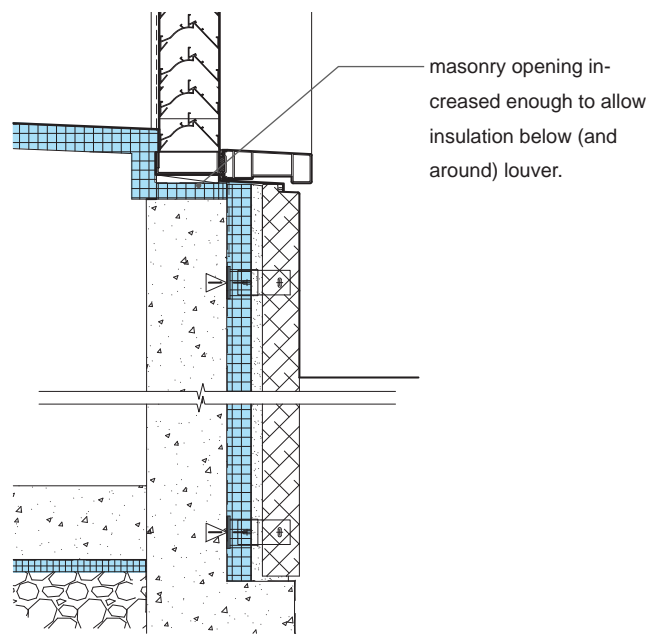
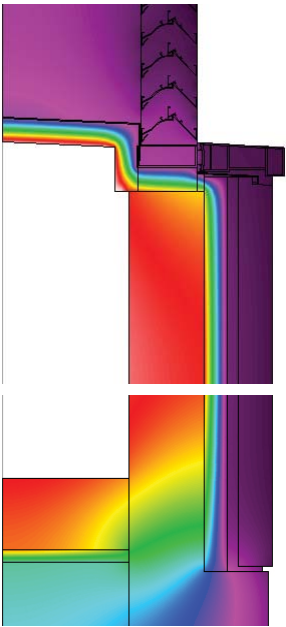
Thermally Improved Condition

R-6.53
(+15%)

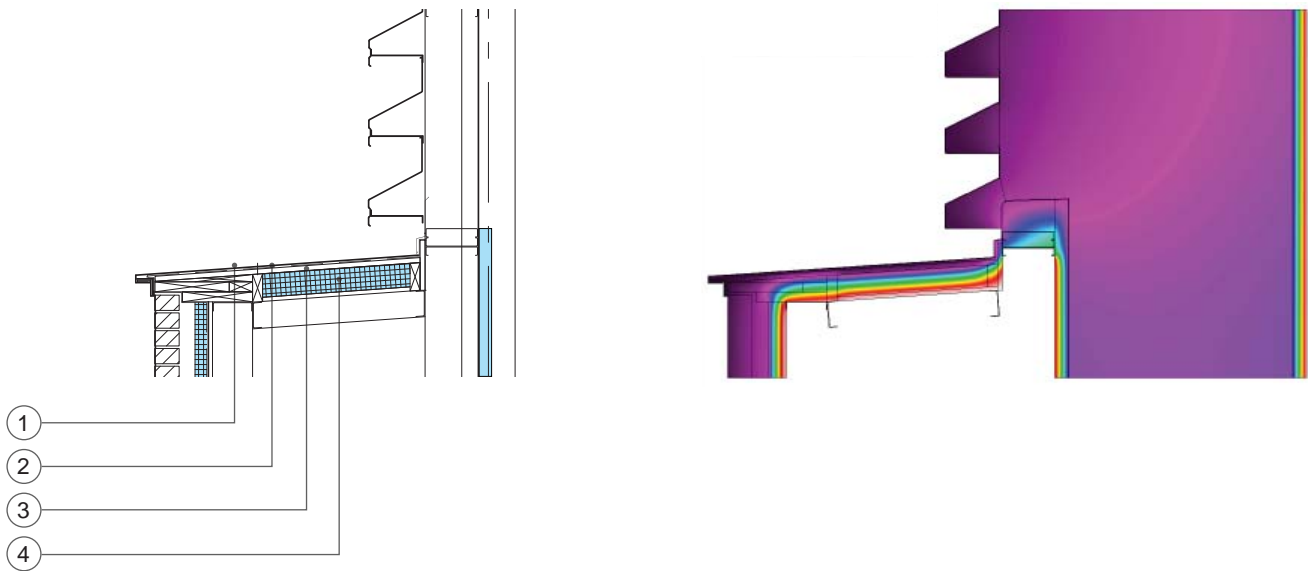
As-Built Condition
Simulated (THERM) R-Value: 16.85

Thermally Improved Condition
See continuous insulation at 13a

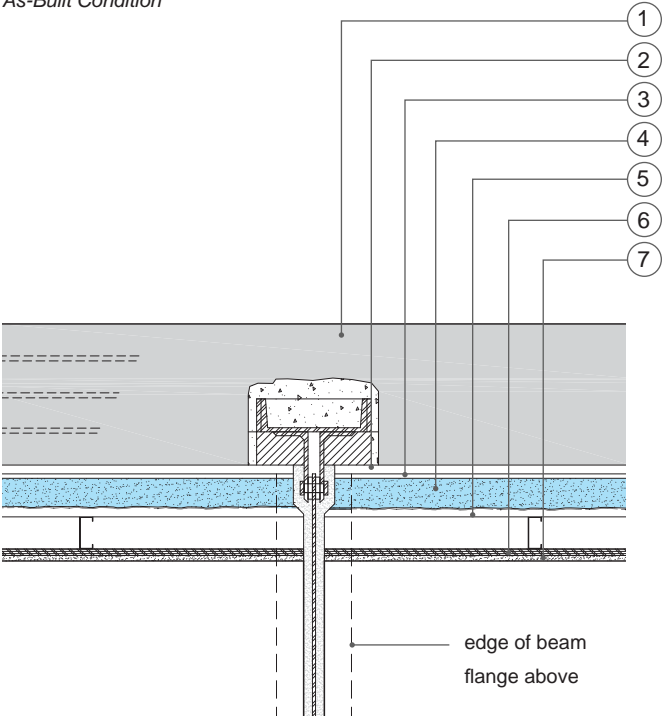
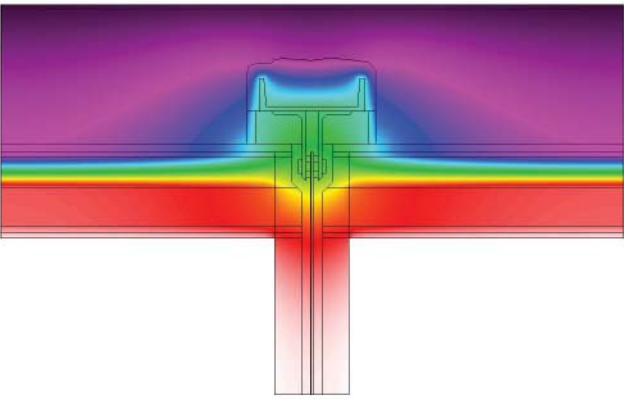
As-Built Condition
Thermal Image R-Value: 8.47 - 71 %
Simulated (THERM) R-Value: 16.62 - 43 %

R-16.62

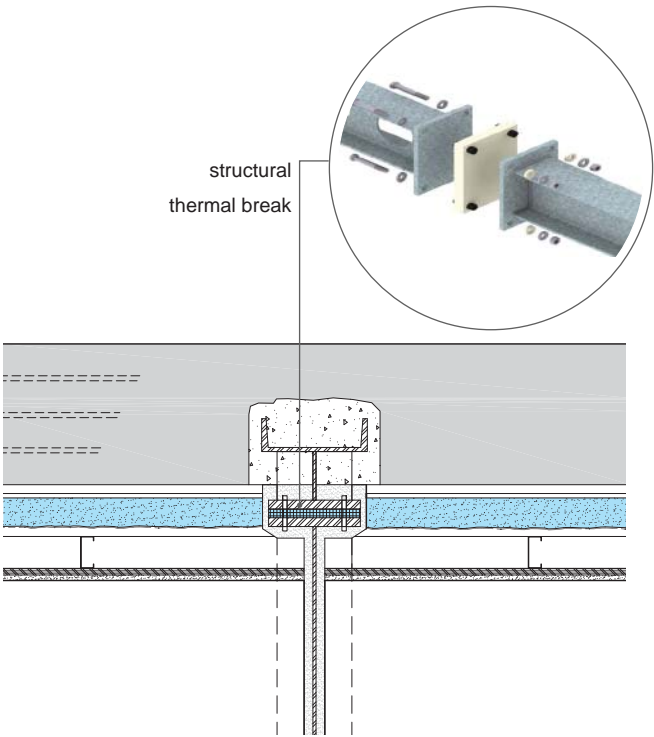
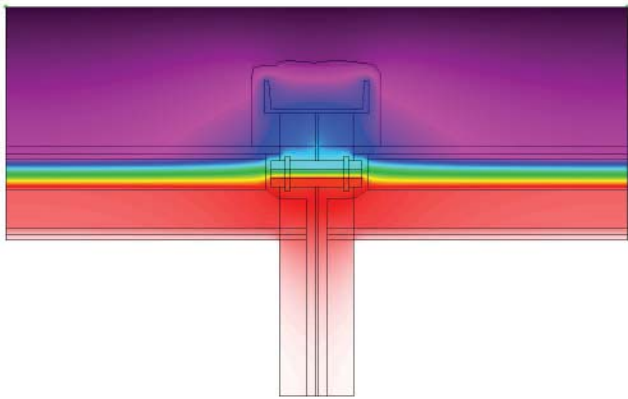
Thermally Improved Condition
Simulated (THERM) R-Value: 22.66 - 22 %

R-22.66
(+36%)

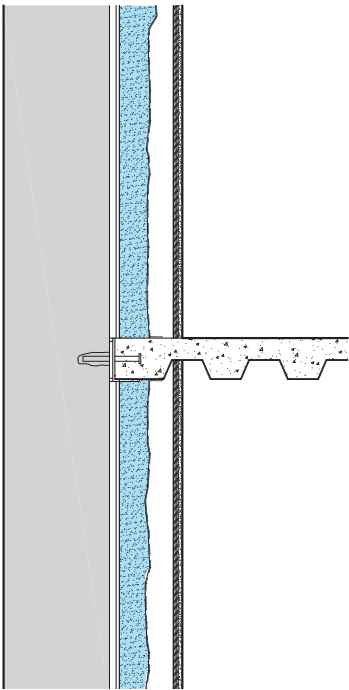
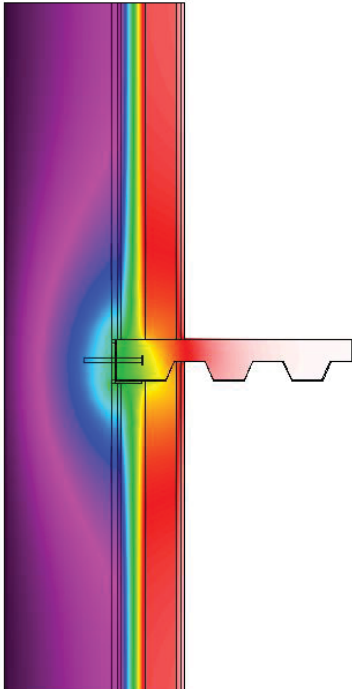
As-Built Condition
Thermal Image R-Value: 15.33 - 48 %
Simulated (THERM) R-Value: 16.14 - 45 %

R-16.14

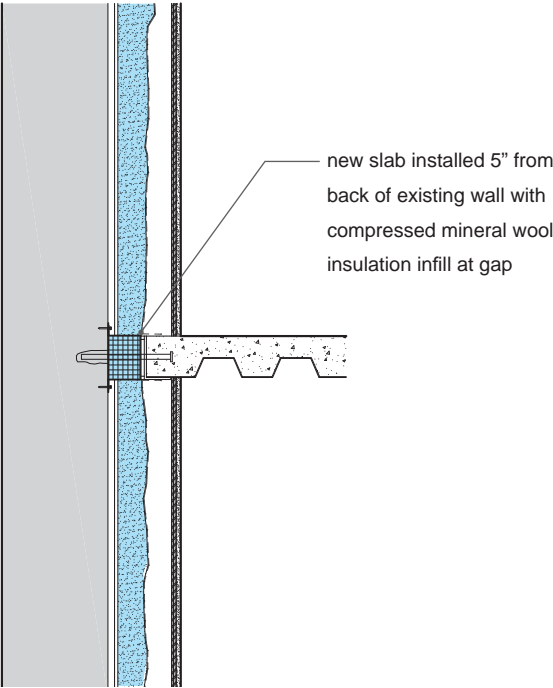
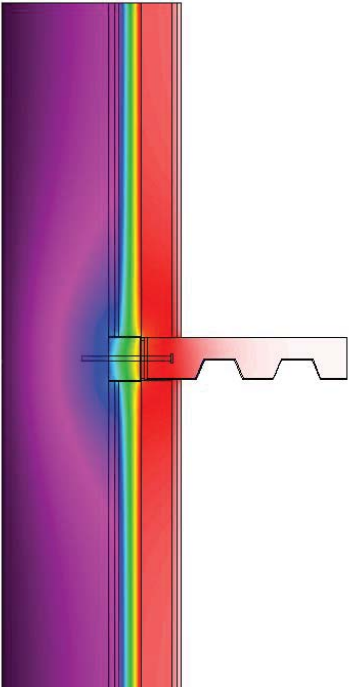
Thermally Improved Condition
Simulated (THERM) R-Value: 21.10 - 29 %

R-21.10
(+30.7%)

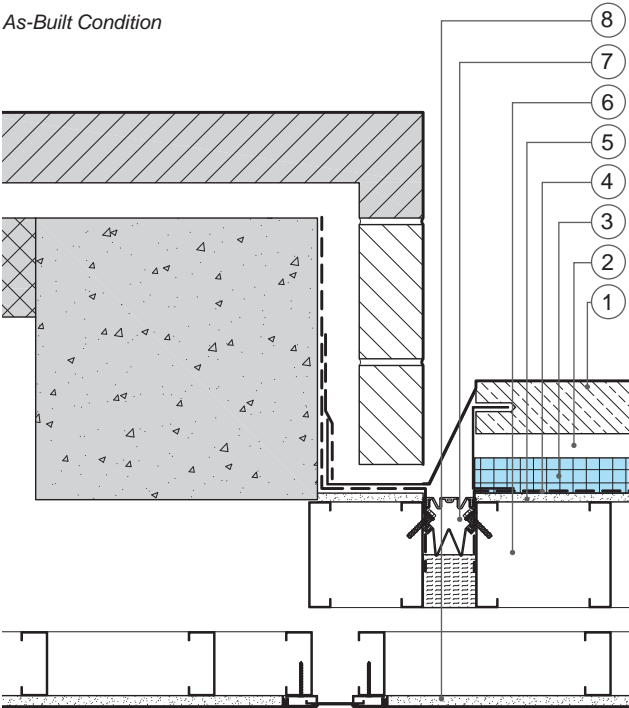
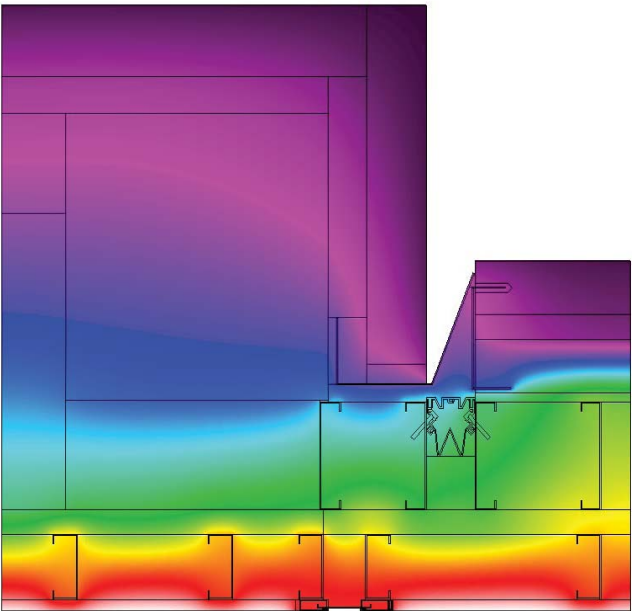
As-Built Condition
Thermal Image R-Value: 6.77 - 62 %
Simulated (THERM) R-Value: 7.88 - 55.5%

R-7.88

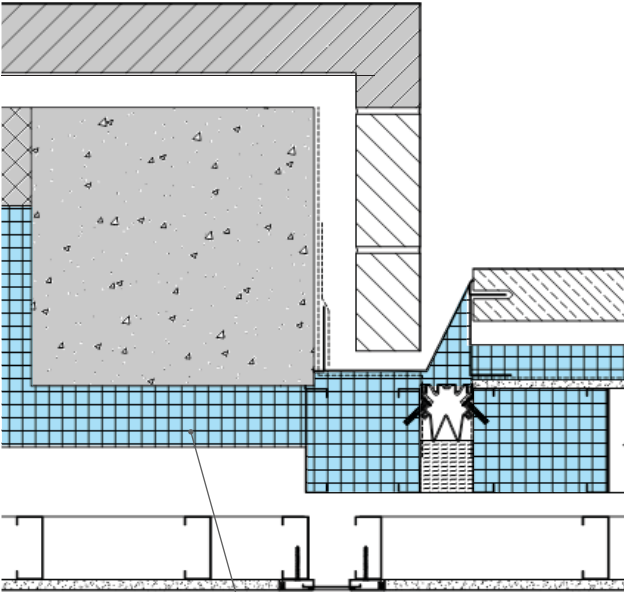
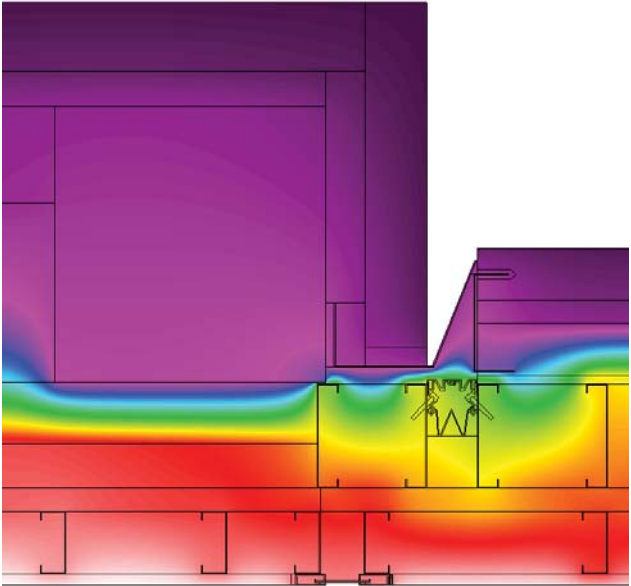
Thermally Improved Condition
Simulated (THERM) R-Value: 13.72 - 22 %

R-13.72
(+74%)

spray foam insulation
added to existing wall,
and at frame for joint

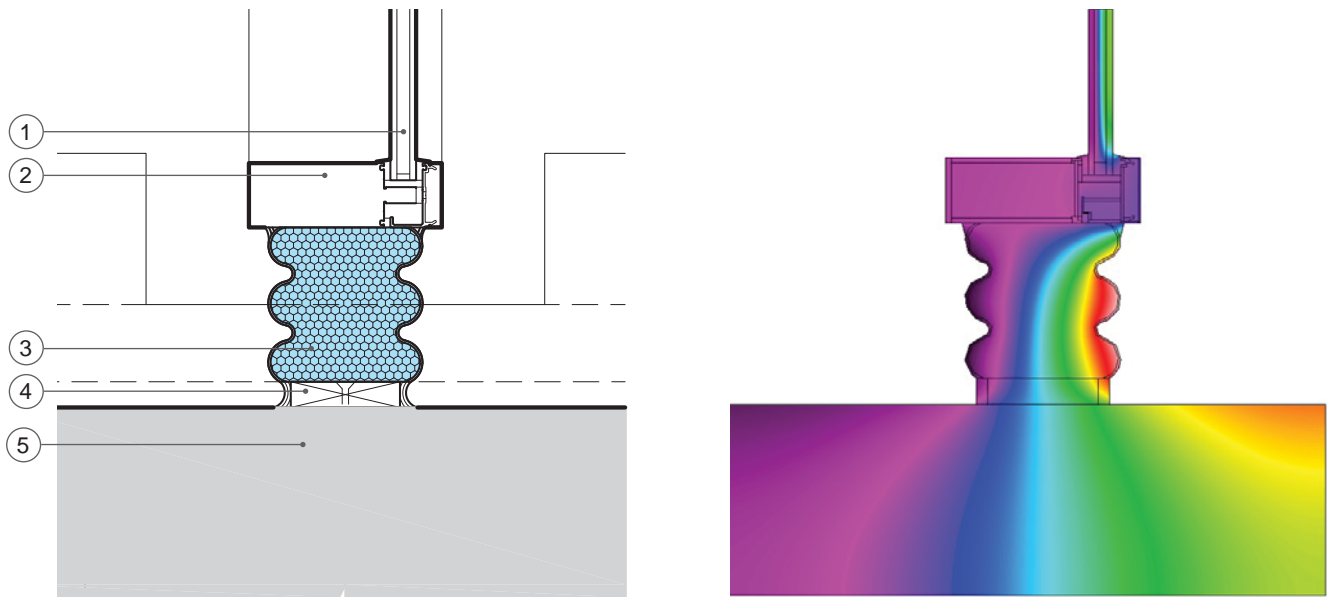
Calculated Baseline R-Value:	11.85	-
As-Built Condition		
Thermal Image R-Value:	N/A	N/A
Simulated (THERM) R-Value:	2.30	- 81%
Thermally Improved Condition		
Simulated (THERM) R-Value:	N/A	N/A
