THERMAL PERFORMANCE OF FAÇADES

2012 AIA UPJOHN GRANT
RESEARCH INITIATIVE

Final Report | November 2014

PAYETTE **RESEARCH**

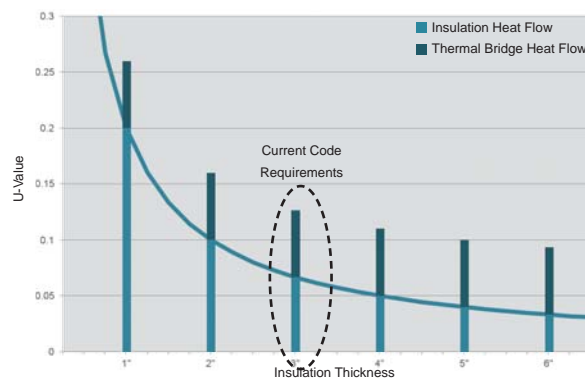
Chart of heat flow through wall assembly and thermal bridge

Thermal bridging in building construction occurs when thermally conductive materials penetrate through the insulation creating areas of significantly reduced resistance to heat transfer. These thermal bridges are most often caused by structural elements that are used to transfer loads from the building envelope back to the building superstructure. Though design professionals generally understand that thermal bridging is a concern, few can quantify the extent of its impact on building performance. With only a vague sense that this is a problem, it is unclear how aggressively we

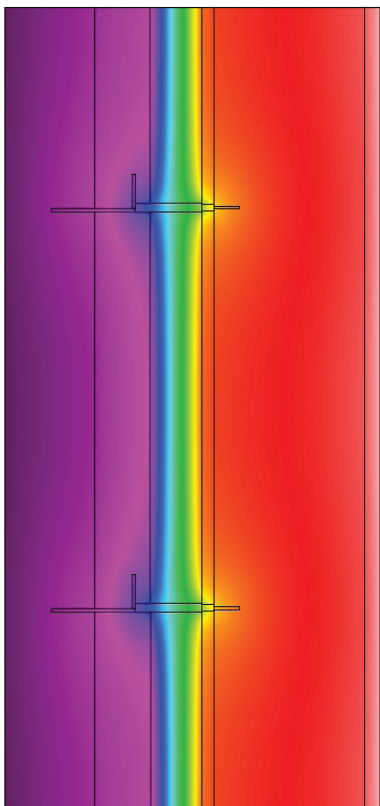
16x16 Galvanized Barrel

R-12.54
(-15%)

This study works with limited variables to see how the spacing, type and material of brick ties affects the R value of the brick venner wall. The back up assumed for this study is light gauge metal framing.

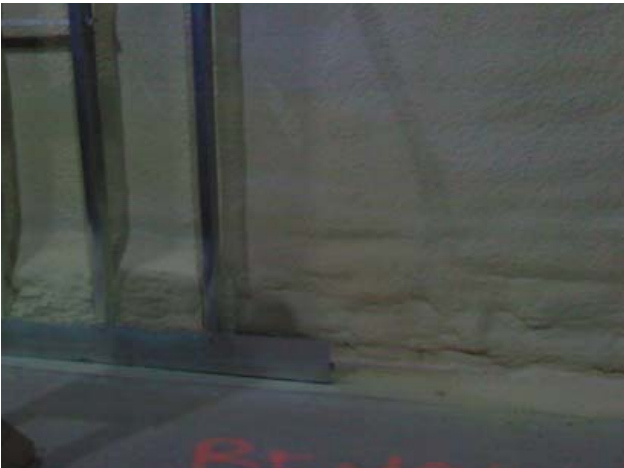
Digital Image

APPENDIX- 15a | NEW SLABS IN EXISTING BUILDINGS: Thermal Break at New Slab
